C3 Waterloo Barrier Installation Report

**Former Gulf States Creosoting Site
Hattiesburg, Mississippi**

WATERLOO BARRIER® SYSTEM INSTALLATION REPORT

**Pine Street & Gordon's Creek
Hattiesburg, Mississippi**

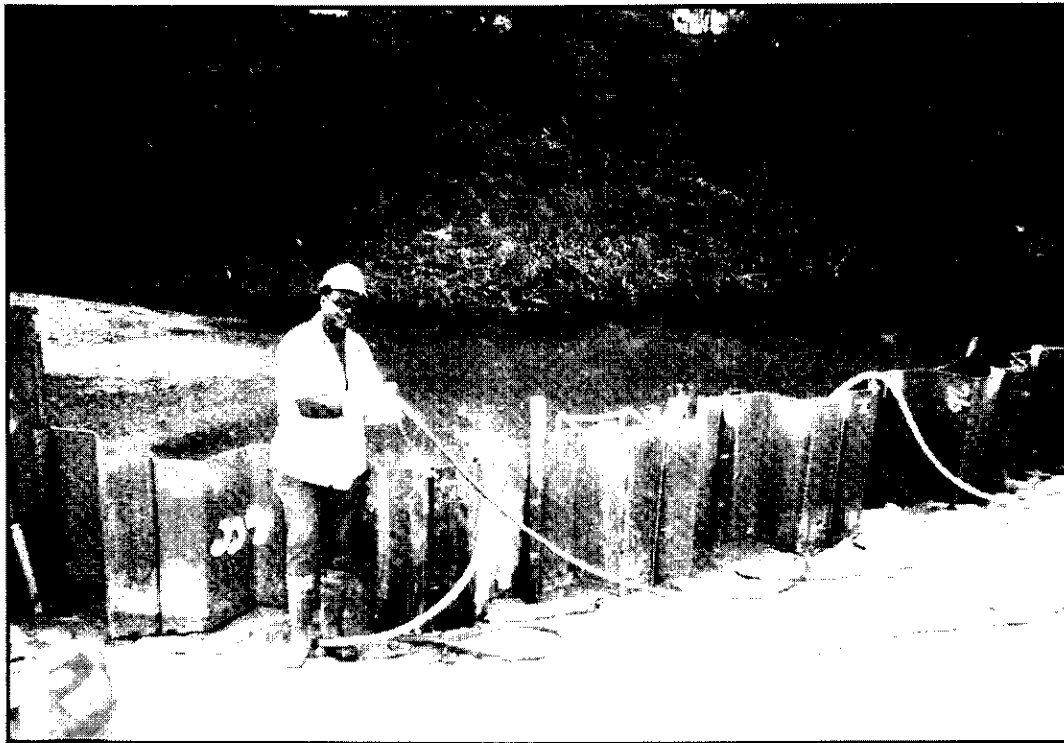
Photo 7.3: Primary Flushing

Inspection of the sealable cavities was the final stage of the Sheet Pile Installation QA/QC Program. Joint flushing equipment was used to inspect the integrity of each of the WEZ95 sealable cavities. The first time a joint was flushed was referred to as primary flushing. Potable water delivered under pressure was used to flush soil and debris out of each joint. Primary joint flushing was completed to ensure that a sound sealable cavity was maintained during installation and that the sealable cavity was free of obstructions for the full length of the sheet. Refer to Appendix F for the Sealable Cavity Inspection Summary. Photo 7.3 shows the flushing of a sealable joint.
