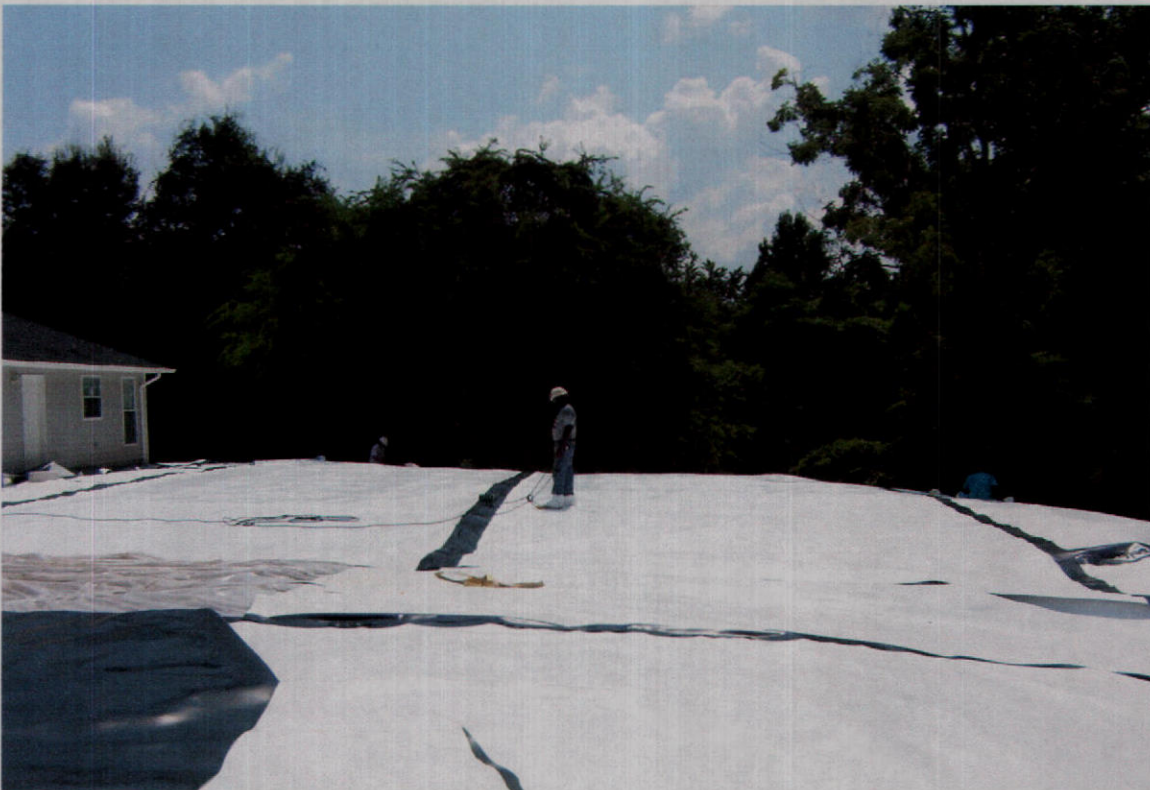
PHOTO 2 – Workers completing the installation of the LDPE protective liner at 114 Brent Street. Photo was taken looking north to south.
