ACKER LAKE LANDSLIDE, MONROE COUNTY, MISSISSIPPI

INFORMATION SERIES MGS-73-1

MISSISSIPPI GEOLOGICAL, ECONOMIC AND
TOPOGRAPHICAL SURVEY

1973

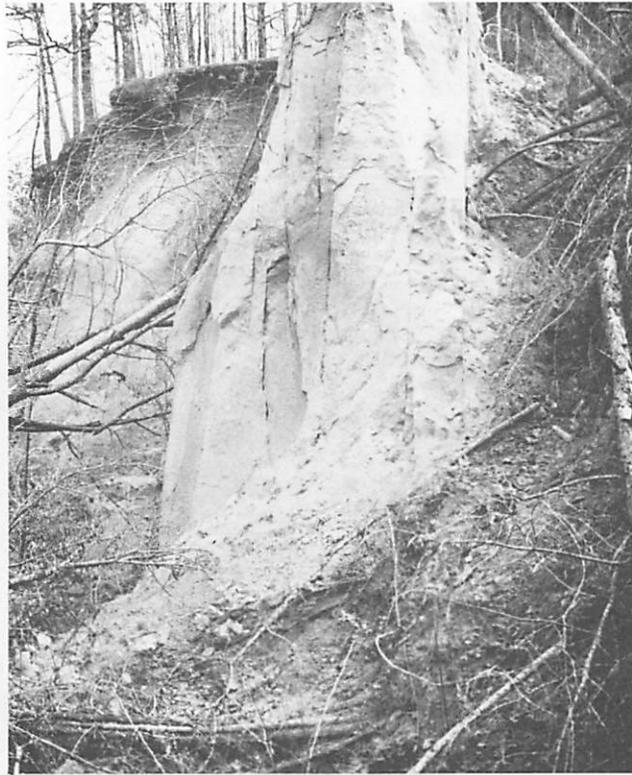
Fig. 6. Blocks of jointed Tombigbee Sand in southern graben area.

The southern graben is smaller, approximately 350 feet by 80 feet (106.7 x 24.4 m), but exhibits many of the features observed in the northern graben. There is no continuous outer block in the southern graben like the prominent block in the northern graben. There are, however, several smaller blocks that have separated from the bluff face (Figs. 5 and 6). In each graben the suddenness of slumping left trees and underbrush in a tangled mass not unlike that resulting from tornadic winds (Fig. 7).

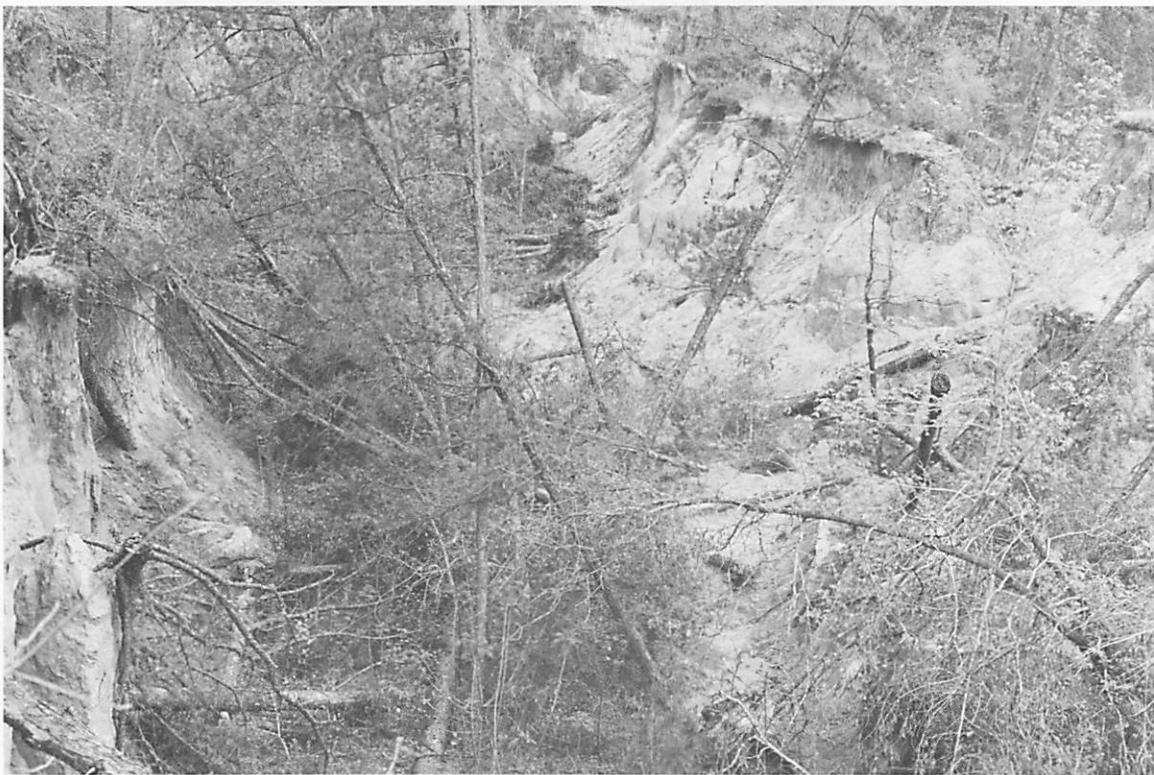
Fig. 7. Looking north in northern graben area. Mississippi State University photograph by Ronald Gunter.

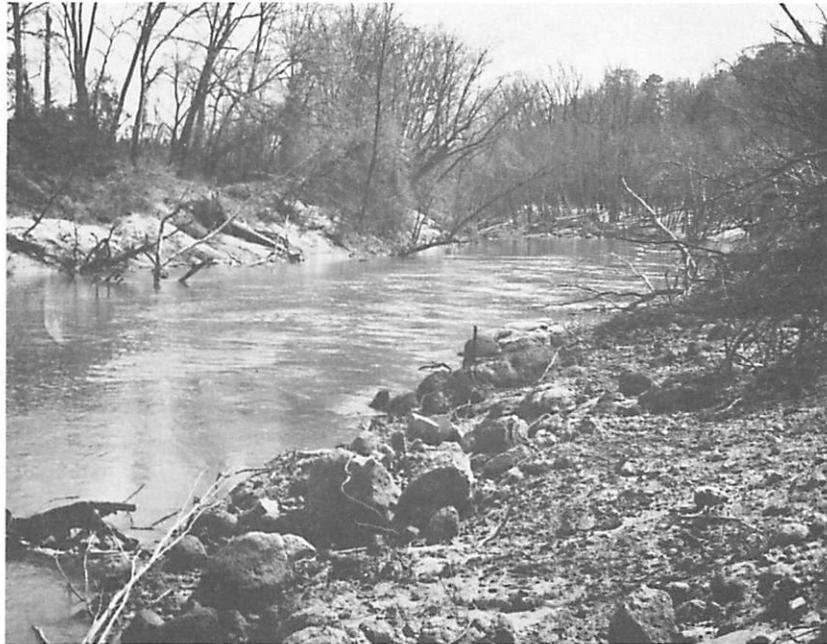
Fig. 8. Clay blocks along lower portion of toe of slide.

Between the graben areas and the river are several features common to slide areas, so that an irregular, hummocky topography has resulted. This area includes small scaps, fractures, and pressure ridges that have developed, at least in part, during movements previous to the 1970 slide. Along the toe of the slide, near the present channel of the river, are banks of sand and blocks of silty, sandy clay (Fig. 8).

eous glauconitic sand. In the interval below the upper 80 feet (24.4 m.) the sands are similar to those above but several significant clay beds are present. The thickness and stratigraphic positions of these clay beds is somewhat variable, but they can be correlated locally. None of the thicker beds was seen on the outcrop; however, blocks of clay were found in the slide area at Acker Lake (Fig. 8). Lignites associated with the clays become more common near the base of the interval.

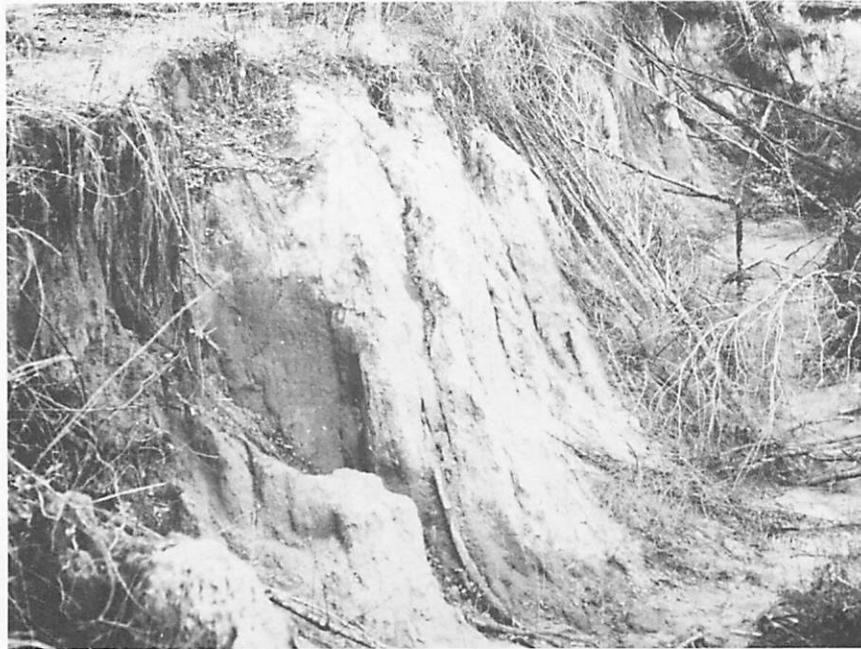
Fig. 10. Joints in Tombigbee Sand along inner scarp of northern graben.

Included on Figure 9 are the coefficients of permeability that were determined from Tombigbee Sand samples collected at the outcrop. Wasson and others (1965) reported that the average permeability of sand in the Eutaw Formation is about 100 gallons per day per square foot (meinzers units), but that the Tombigbee Sand Member is probably less permeable than the lower part of the Eutaw. The permeability values obtained in this study range from less than one to as much as 51.6 meinzers, which agree in magnitude with the findings of Wasson and others. It is well known that small samples used to determine permeability may yield unreliable results and that anomalous values should be expected. In most samples the permeability in the horizontal direction was greater than that in the vertical direction. Anomalous values could generally be attributed to features such as fractures, clay fragments, undetected root structures, and borings. These features that tend to increase permeability are common near the tops of bluffs. Joints are of particular importance, and are numerous at Acker Lake bluff (Fig. 10). Roots up to half inch in diameter were noted in joints.

Another important factor in the development of the graben part of the slump is the movement of water from Acker Lake into the joints near the edge of the bluff. The joints are probably a result of unloading along the bluff face, and are concentrated near the edge of the bluff. As previously noted, water seeps into the alluvium continually along joints, thus maintaining a high moisture content in these areas. This in turn probably increases the pore moisture and decreases the shearing strength of the sands; consequently, they collapse when support is removed.
