MISSISSIPPI DEPARTMENT OF ENVIRONMENTAL QUALITY

FACT SHEET

Equalization Lagoon Closure Grenada Manufacturing, LLC Grenada, Mississippi

January 2016

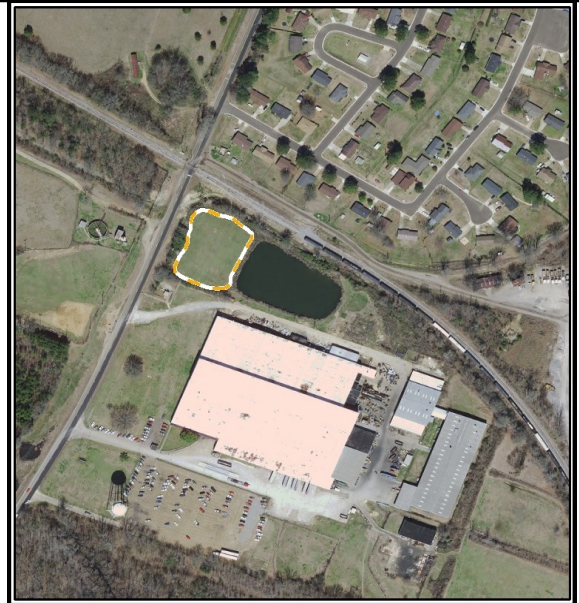
Aerial Photograph of the RCRA regulated unit (grassy area west of pond).

The former Equalization Lagoon (SWMU 2), located northwest of the main plant building, was closed under MDEQ jurisdiction as a regulated unit in 1994. Prior to 1991, the Equalization Lagoon received process wastewater flows from the roll-forming department, boiler blowdown, boil-off, butler wash, buff wash, alkaline rinse water, and cooling waters. After 1991, wastewater was routed directly to the facility's wastewater treatment plant.

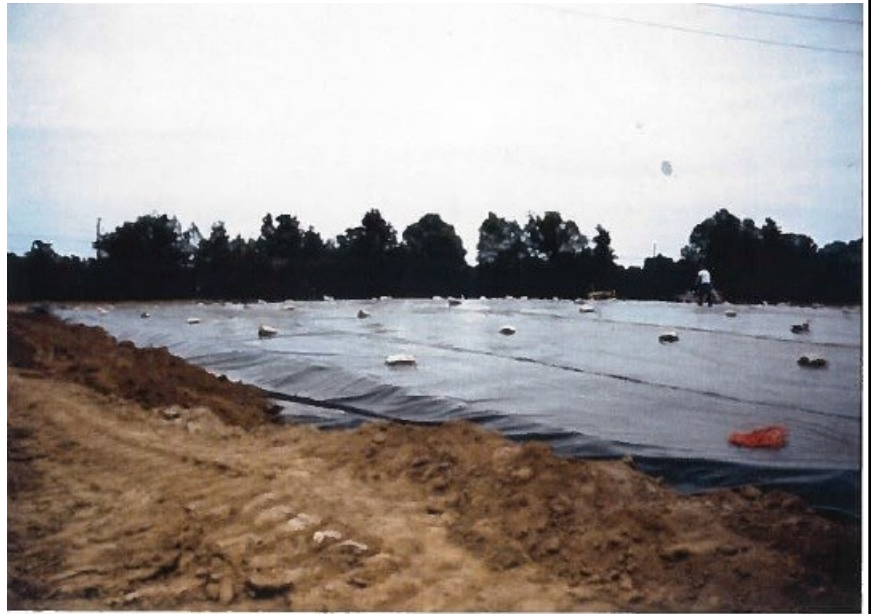
Installation of plastic cap during closure of the Equalization Lagoon in 1993

In 1991, MDEQ issued an Administrative Order requiring a RCRA Permit for the equalization lagoon (Lagoon). Mississippi required Textron to close the equalization lagoon in an engineered landfill cell (or impoundment) designed by a Professional Engineer. The Lagoon was drained, and the resulting wastewater was sent to the wastewater treatment plant prior to discharge. The sludge and underlying soils were excavated, dewatered, and staged on the eastern side of the Lagoon footprint. An engineered plastic liner was then constructed within the western portion of the Lagoon and the consolidated sludge and underlying soil mixture was placed within the lined area. An engineered plastic landfill cover system was placed on top, encapsulating the waste material. Lastly, the eastern side of the Landfill footprint was backfilled with one foot of clean clay material, and the eastern portion of the former Lagoon was allowed to be reclaimed as a pond. Currently, the pond is not used as part of any industrial processes at the facility.
