Reference: EPA Contract No. 68-01-7038; Work Assignment
No. R04-03-75; Kerr-McGee Chemical Corporation,
Columbus, Mississippi (MSD 990866329); Interim
RFA Report

Enclosed please find the Interim RCRA Facility Assessment Report (RFA) for the Kerr-McGee Chemical Corporation facility. This assessment resulted in the identification of 41 solid waste management units (SWMUs) and one other area of concern (AOC).

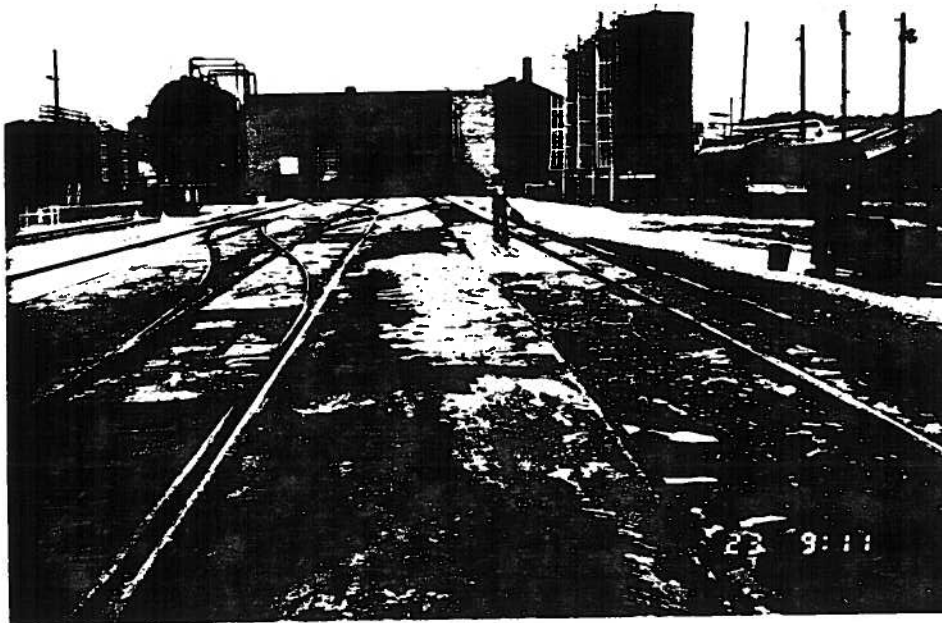
- 1.1 Overview of Front Door Pit (SWMU 1), facing west. The three pressure cylinders are located behind this unit. Work Tank 1 (SWMU 8) and Work Tank 2 (SWMU 9) are located immediately to the left and the Drip Track (SWMU 34) is in the foreground. Note the extensive staining on the Drip Track (SWMU 34).

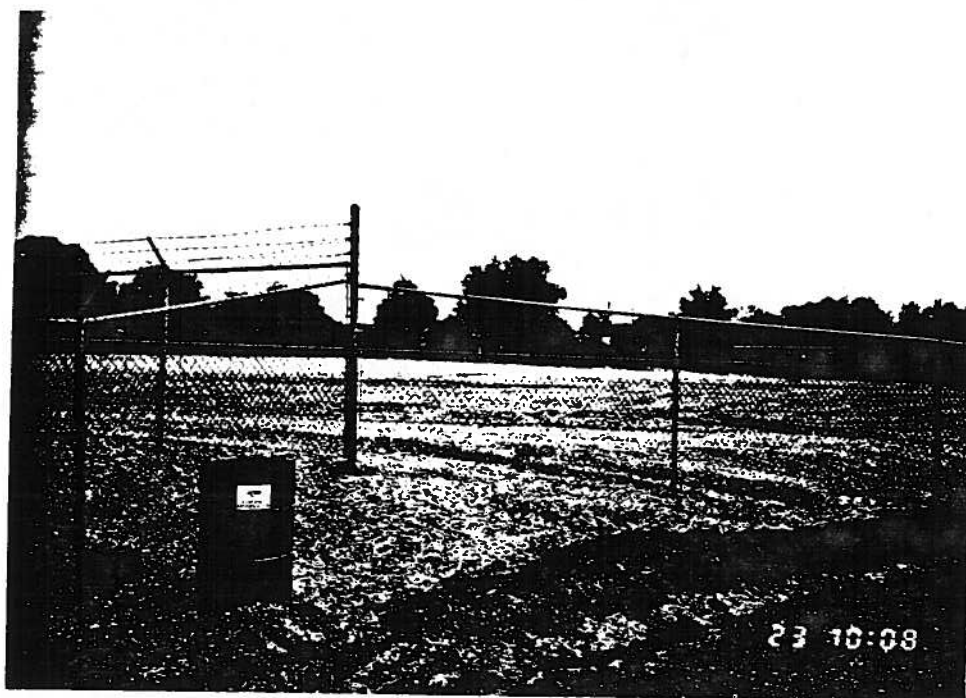
28.2, Close-up view of Aeration Impoundment (SWMU 28), Sedimentation
29.2, Impoundment (SWMU 29), Sand Filter Bed 1 (SWMU 30) and Sand Filter
30.2, Bed 2 (SWMU 31) are located in this fenced area, facing northwest.
31.2 Note the Drainage Ditch (SWMU 37) in the foreground.

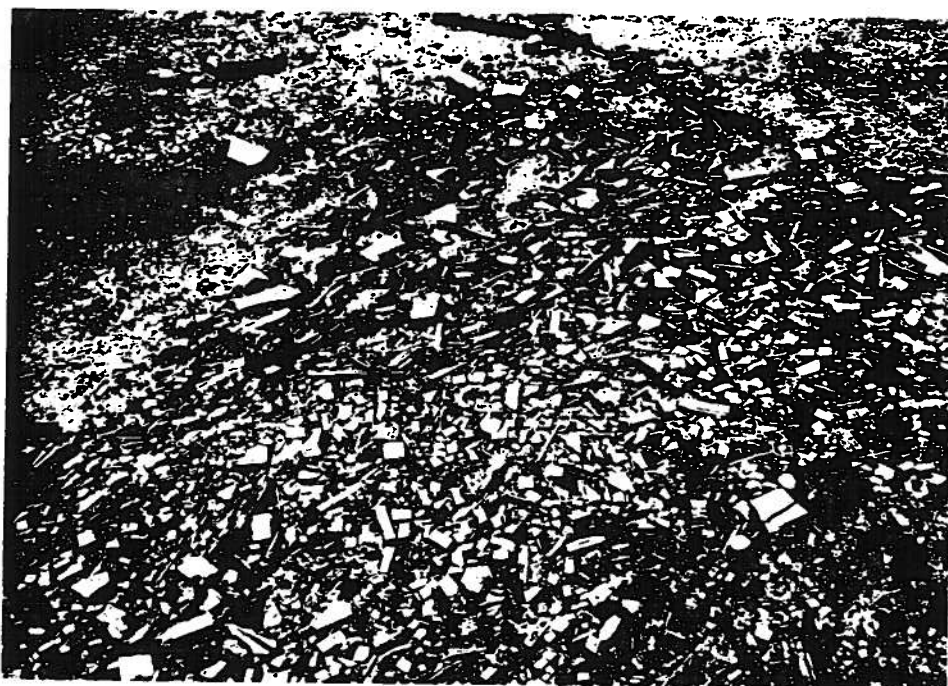
32.2, Closeup view of Waste Pile 1 (SWMU 32) and Waste Pile 2 (SWMU 33).
 33.2 Note the wood debris remaining from the former unit and dark staining on
 the soil at upper left corner of photograph.

30. Sand Filter Bed 1 31. Sand Filter Bed 2 32. Waste Pile 1 33. Waste Pile 2	The potential for release to air and surface water is low due to the discontinued use of the units. The potential for release to soil and groundwater is high due to the unlined nature of the units. The potential for release from subsurface gas generation is low due to the nature of the wastes managed.	Conduct soil sampling in the area to determine if hazardous constituents have been released.

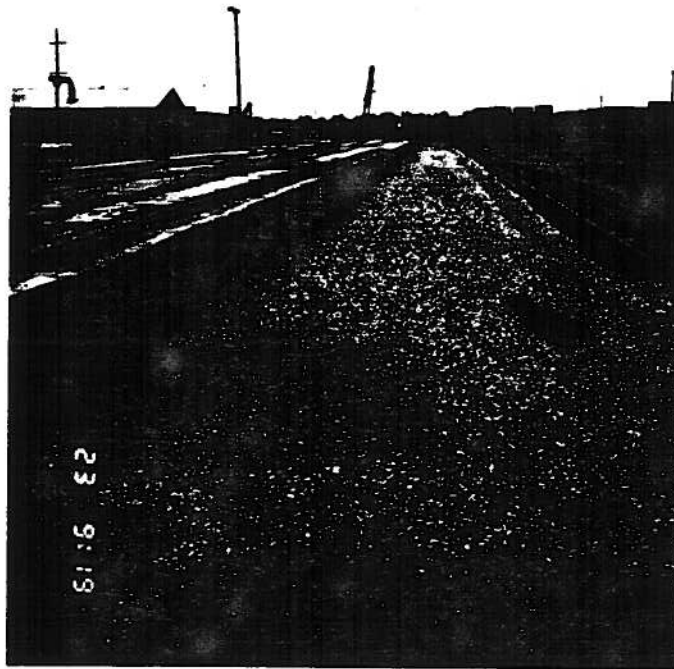
34. View of the Drip Track (SWMU 34), facing east. Note the creosote on the concrete between the tracks to the left and some drippage on gravel and ties to the right. The Black Tie Storage Area (SWMU 36) is located in the background. Refer to photograph 1.1 for a close-up view of the Drip Track (SWMU 34).

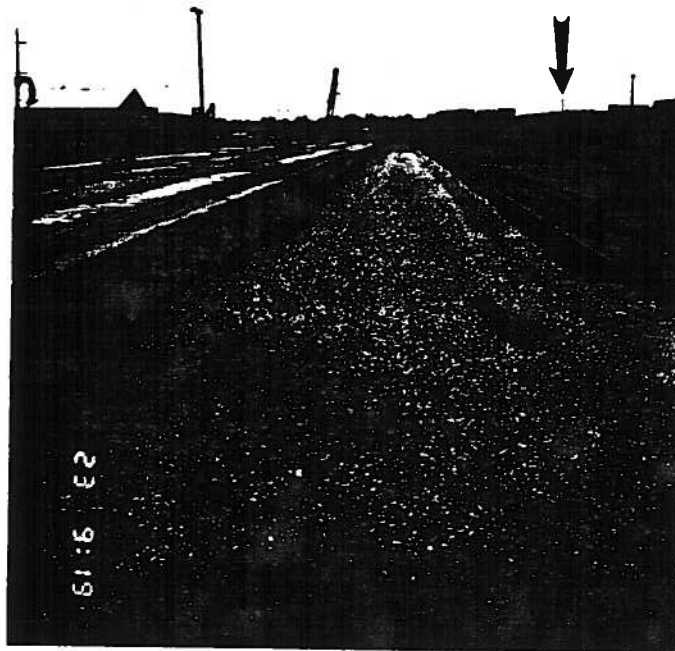
36. View of the Black Tie Storage Area (SWMU 36) (indicated by arrow), facing east. The Drip Track (SWMU 34) is located in the left foreground.

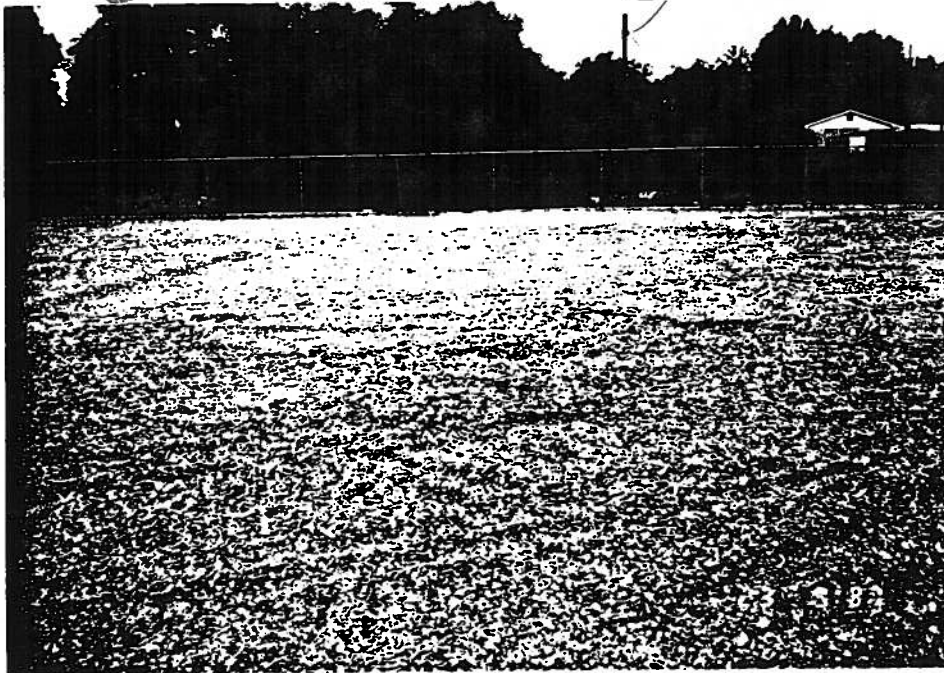
38.1 View of the closed Cooling Tower Surface Impoundment (SWMU 38), facing west. Note the close proximity of the residences in the right background.

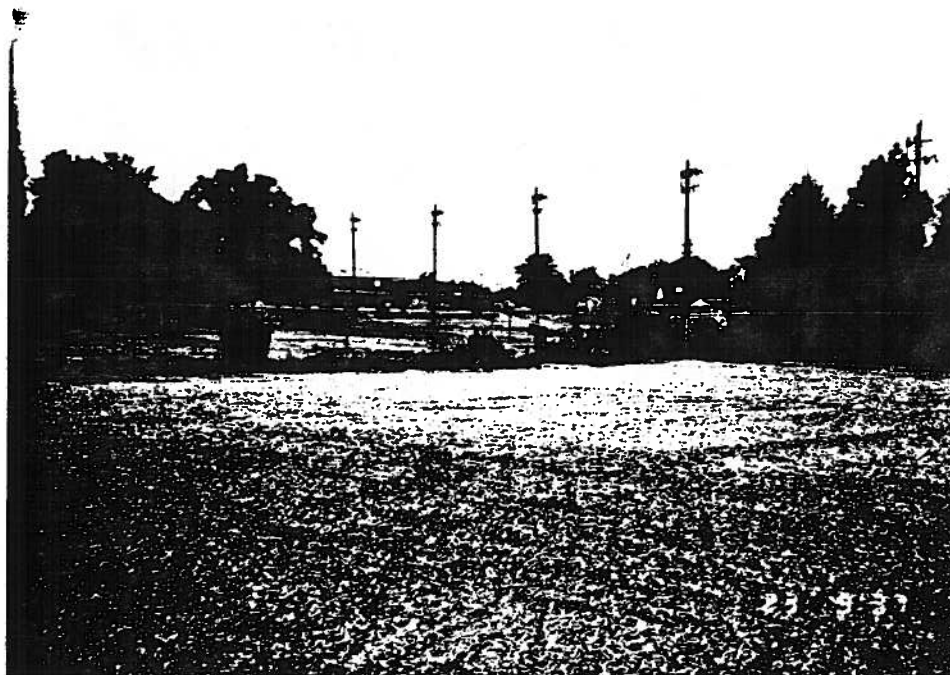
38.2 View of the closed Cooling Tower Surface Impoundment (SWMU 38), facing west. Note the close proximity of the residences.
