Former Hercules Facility Hattiesburg, Mississippi

February 4, 2021

Conceptual Site Model and Follow Up Investigations

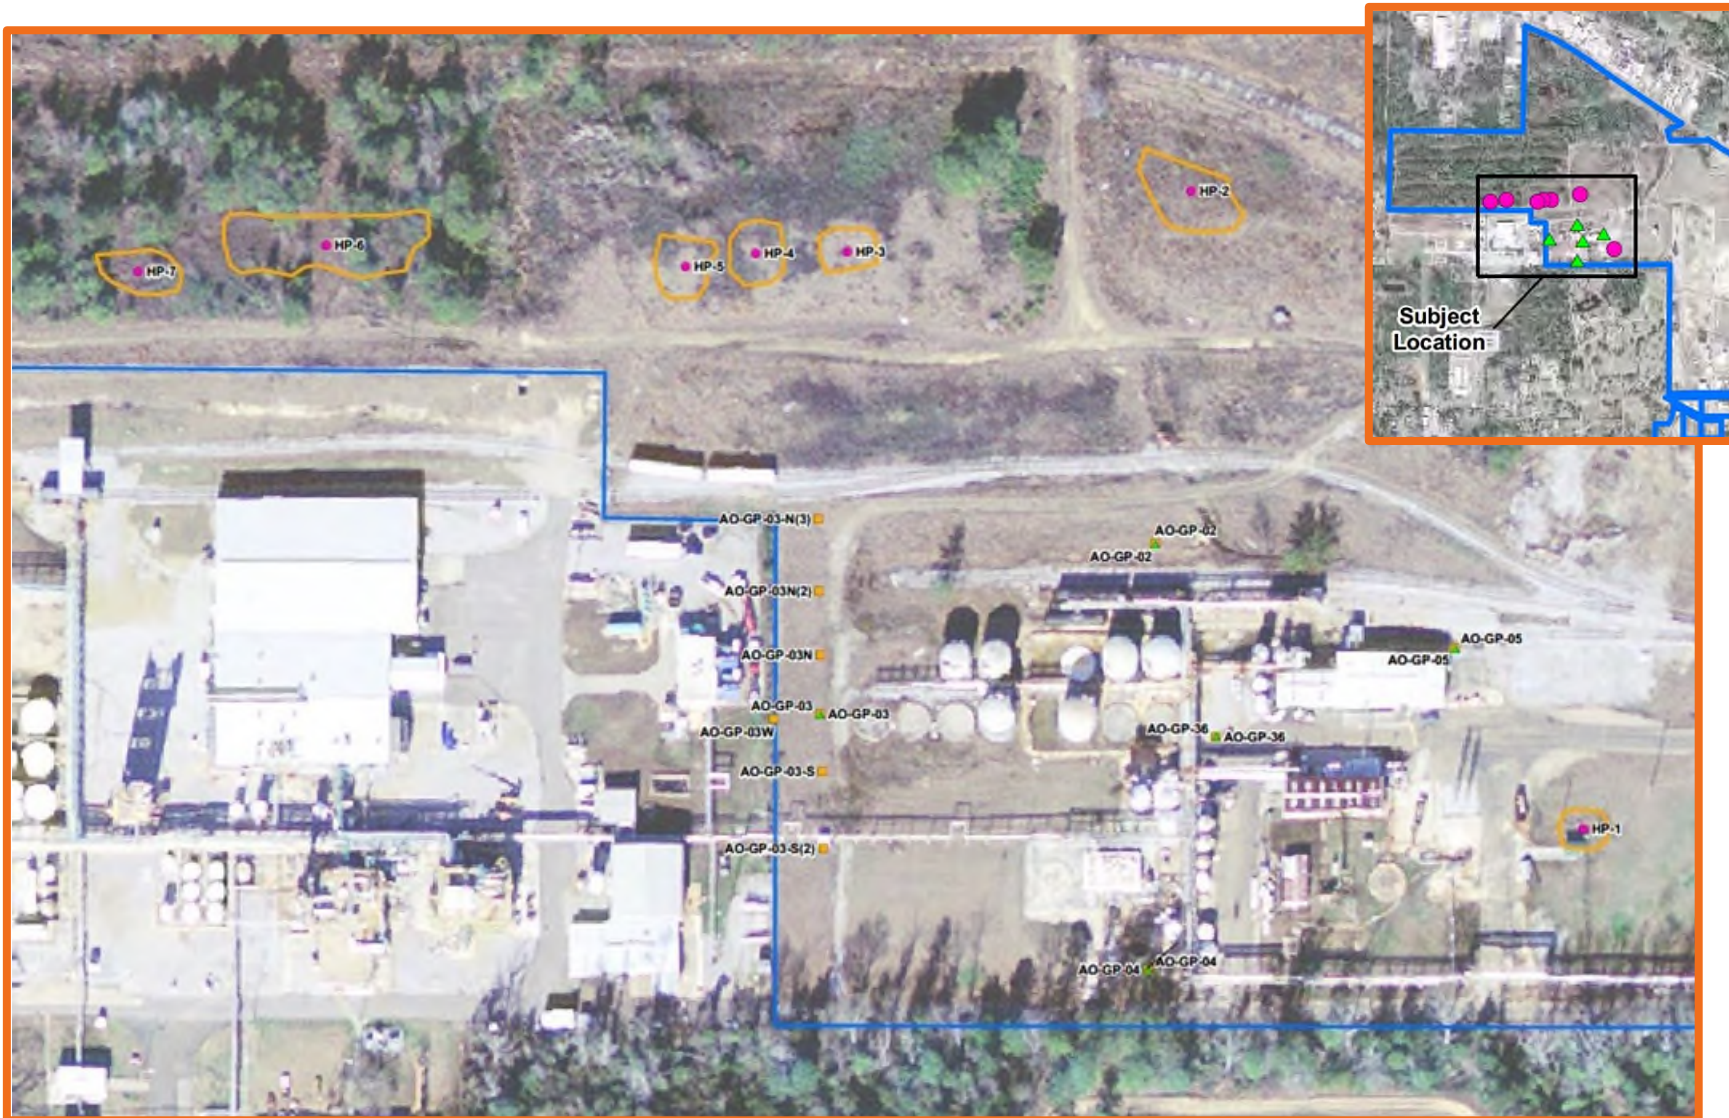
Historical Features Investigation

- No additional sources and findings consistent with previous investigations
- Data incorporated into risk assessment
- Identified during interpretation of historical aerial photography (1937 to 2015)

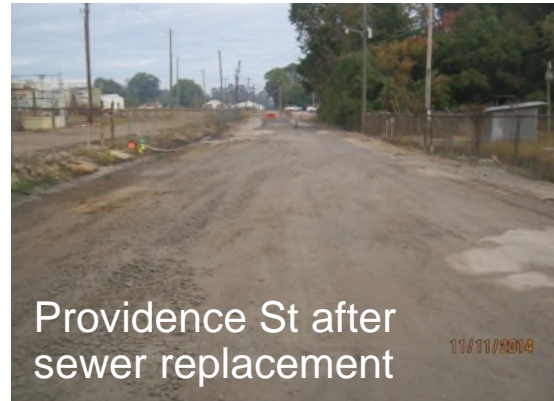
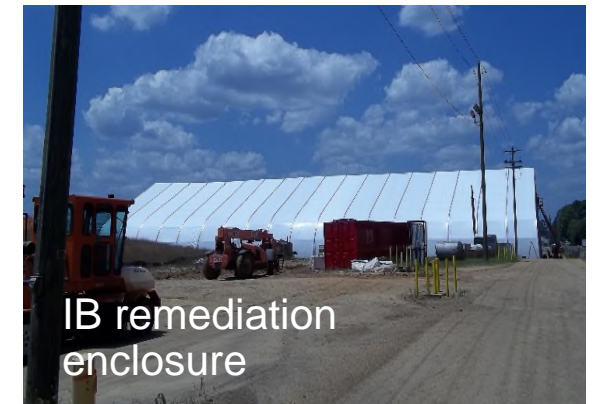
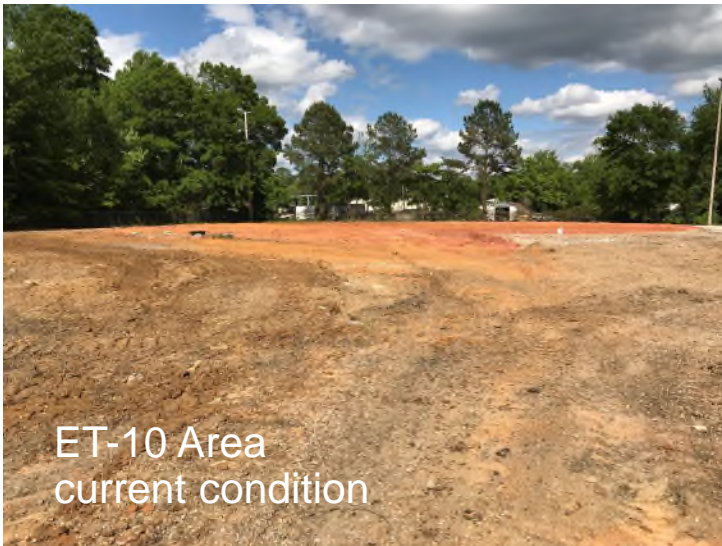
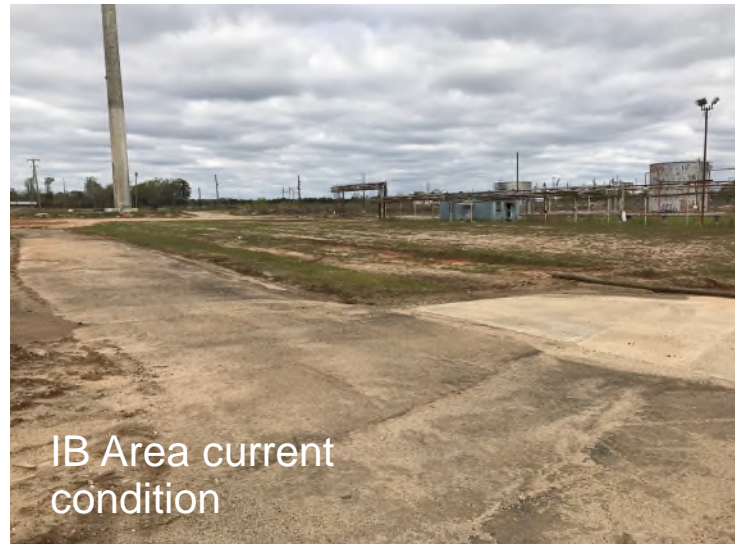
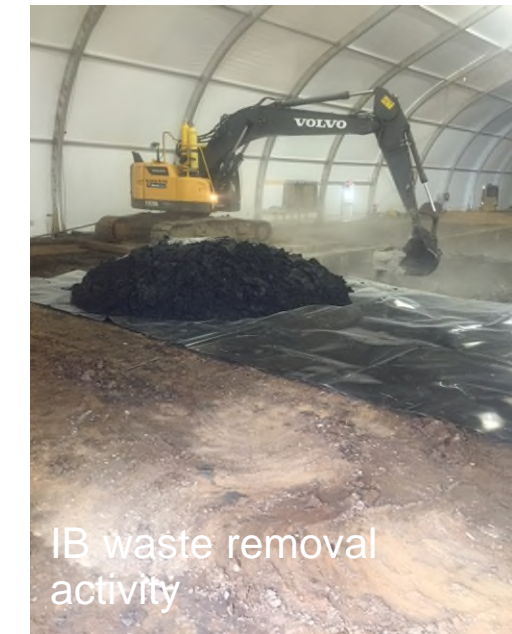
Completed Remedial Measures

- Sewer replacement along Providence Street
- Waste removal, stabilization, backfill, and capping of former impoundment basin (IB)
- Waste removal, stabilization, and decommission of ET-10
