C3 Waterloo Barrier Installation Report

**Former Gulf States Creosoting Site
Hattiesburg, Mississippi**

WATERLOO BARRIER® SYSTEM INSTALLATION REPORT

**Pine Street & Gordon's Creek
Hattiesburg, Mississippi**

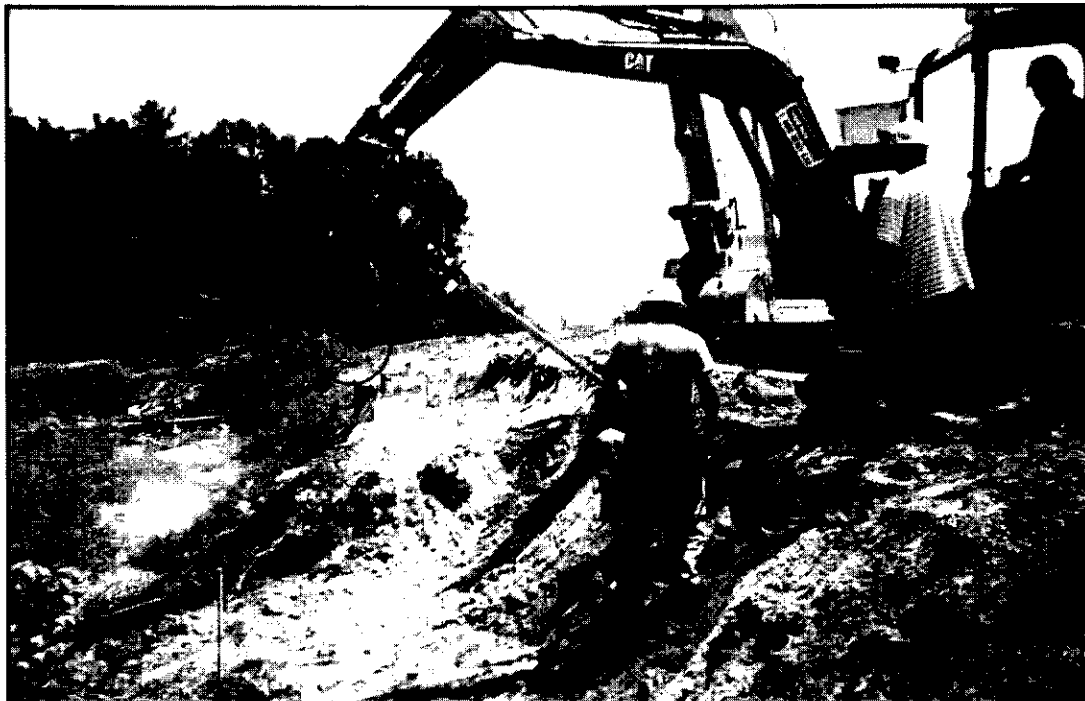
Photo 7.9: Typical Tieback Installation

The Chance[®] helical tiebacks were installed with a Hubbell 12,000 ft/lb installation motor attachment and a DPI (differential pressure indicator). A total of 22 tiebacks were installed along the creek stretch of wall, one tieback at each end of a waler section. C3 hired Engineering Testing Services to witness a load test to determine the torque required during installation to ensure that the required load would be sustained by the tieback. The load test was performed on May 27, 2003 under the supervision of Jerry Buckett of Engineering Testing Services. The a torque of 1350 psi was required during the installation of the tiebacks. Table 7.1 is a summary of the torques achieved during the installation of each tieback and the installation depth (refer to Appendix I for more detailed information regarding the installation of the tiebacks). Photo 7.9 shows a typical tieback installation. Once the tiebacks were installed, holes were cut in the cut-off wall at each tieback location and threaded extension arms were placed through the wall and fastened to the tiebacks.
