Contingency Plan

Former Gulf States Creosoting Site Hattiesburg, Mississippi

Project No. 21-04

MICHAEL PISANI & ASSOCIATES, INC.

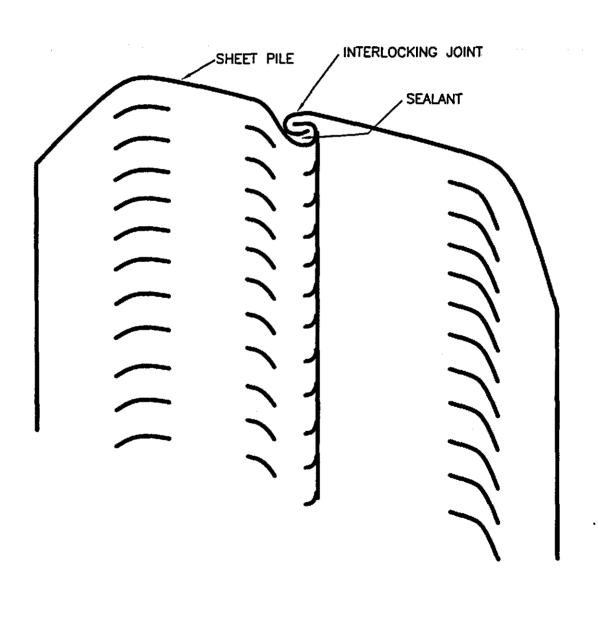
SCALE: NTS DWG. NO.: 21-04/238A FIGURE 5-3 SEALABLE SHEET PILE JOINT

Sealable-joint sheet pilings are similar to conventional pilings, but have interlocking joints between individual pilings that incorporate a cavity. After driving, this cavity is filled with sealant to prevent leakage through the joints (Figure 5-3). Standard pile driving equipment and techniques are used to construct the vertical barrier. A footplate at the bottom of each cavity displaces soil as the pilings are driven, keeping the joints largely soil-free. A water-tight sealant (e.g., cement-bentonite grout) is then injected into the sealable cavities to minimize the potential for leakage between individual pilings. Additional information on sealable-joint pilings is provided in Appendix D.

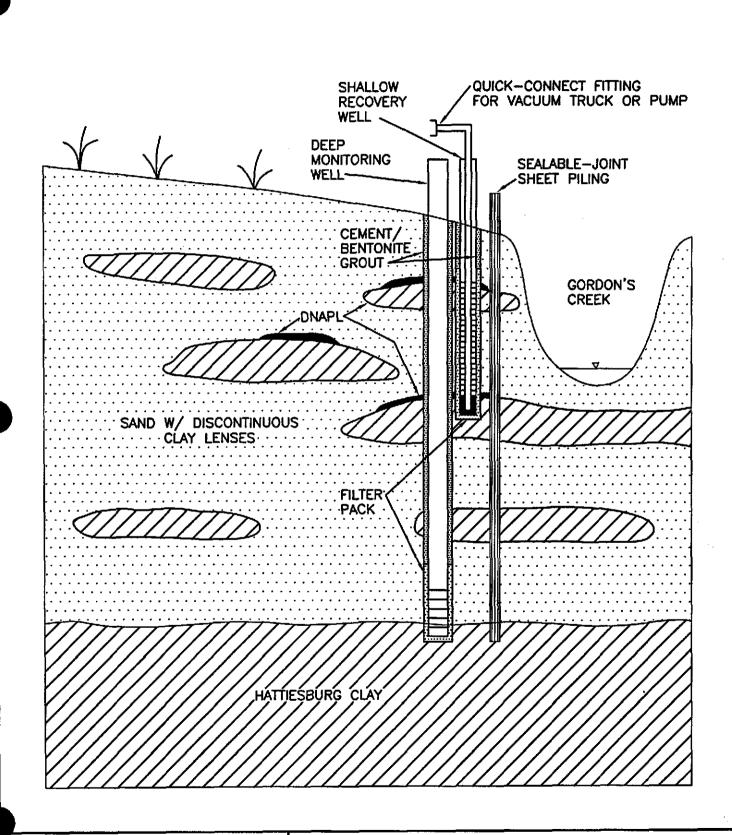
FIGURE 5-4
DNAPL RECOVERY AND MONITORING SYSTEM SECTION VIEW
FILL AREA

Figure 5-4 is a schematic drawing of the proposed DNAPL recovery and monitoring system. Proposed locations of recovery and monitoring wells are shown on Figure 5-5.
