7300–Facilities  
January 2012  
1273–2805P–MTDC  
FEMA P–911

# **Pocket Safety Guide for Dams and Impoundments**

**0E02L32 Impoundment/Dam Safety Pocket Guide**  
**January 2012**

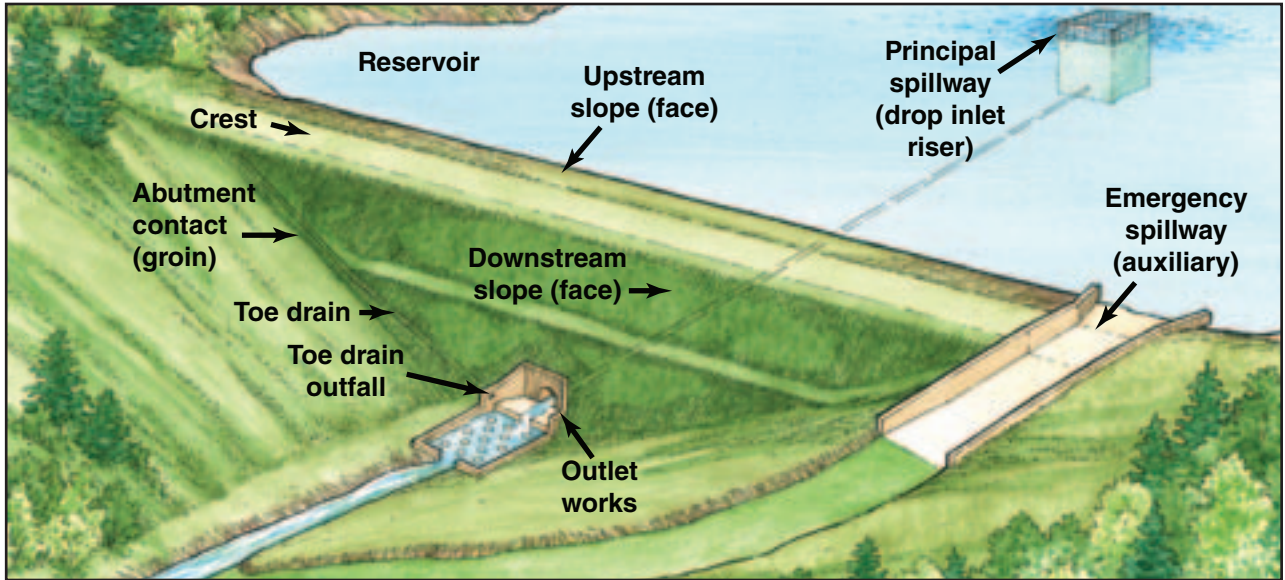
Figure 1—Typical dam diagram showing common terms.

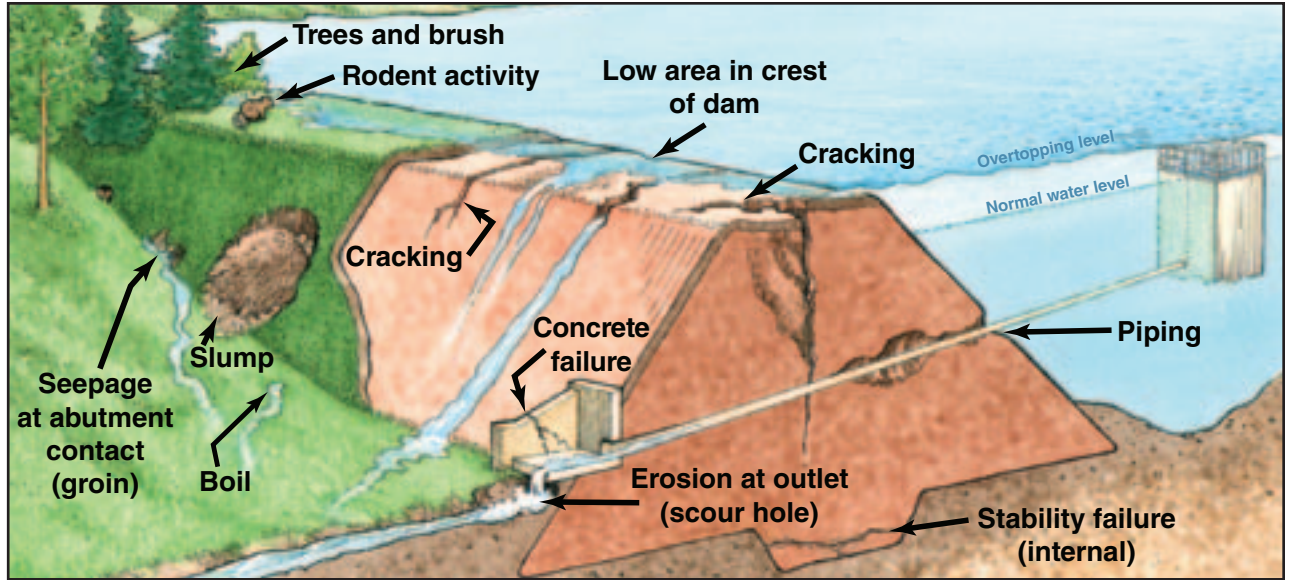
Figure 2—Some causes of dam failures.

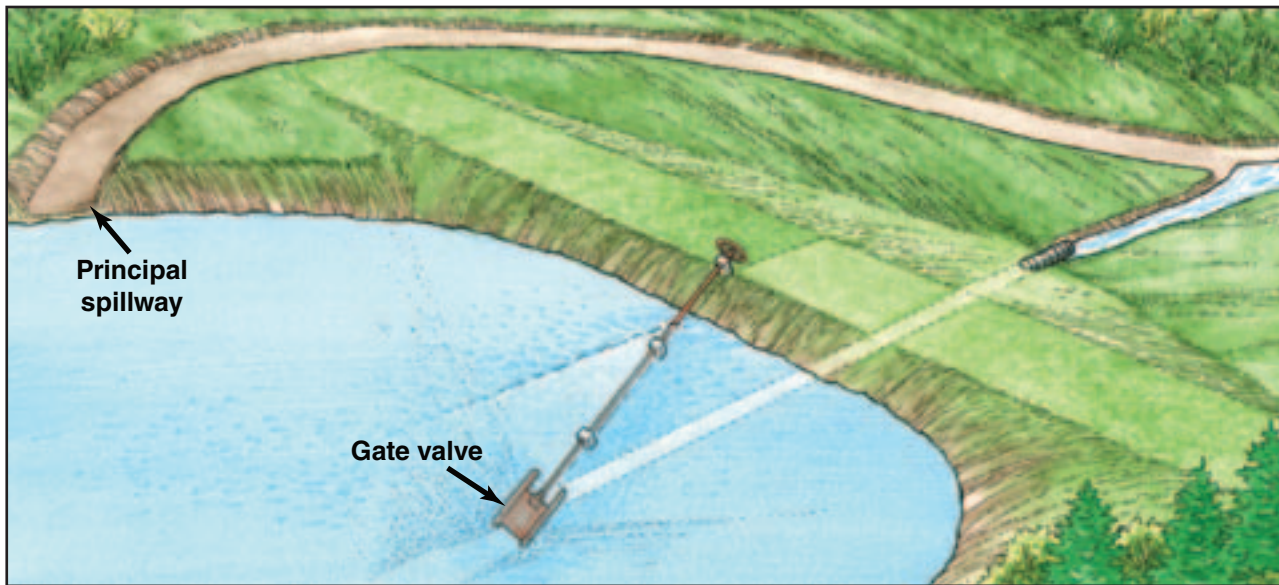
Figure 3—Typical gate valve used with a principal spillway to control water level.

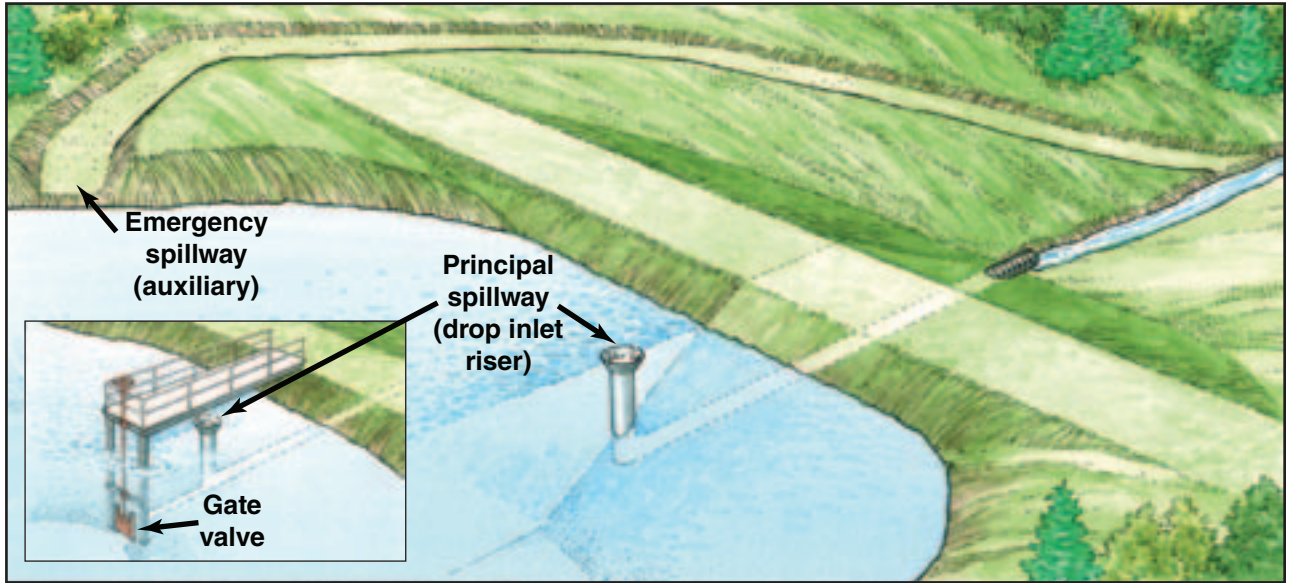
Figure 4—Typical drop inlet riser serving as a principal spillway to control water level.

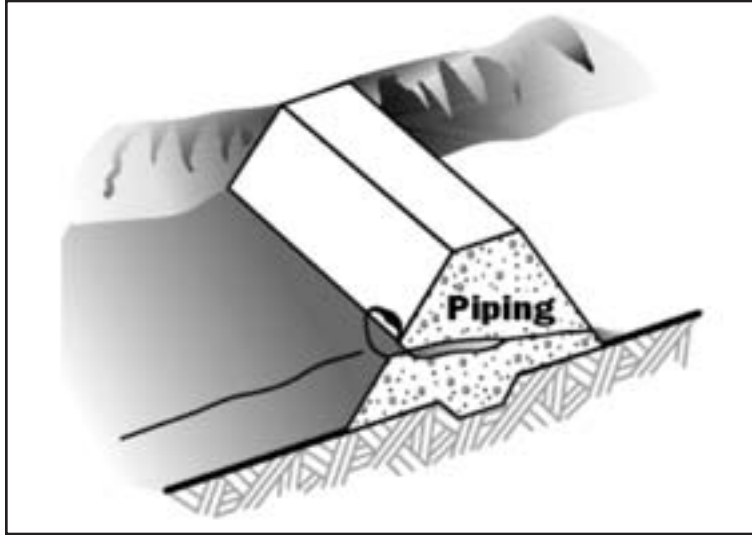
- Internal erosion of embankment materials or the foundation (piping) can cause a sinkhole.
- An eroded cavern (cave-in) can result in a sinkhole.
- A small hole in the wall of an outlet pipe can develop into a sinkhole.
- Water with sediment at the exit indicates erosion of the dam.
- Piping can empty a reservoir through a small hole in the wall. It also can lead to dam failure as soil pipes develop and erode through the foundation or a pervious part of the dam.

Figure 5—Sinkholes.

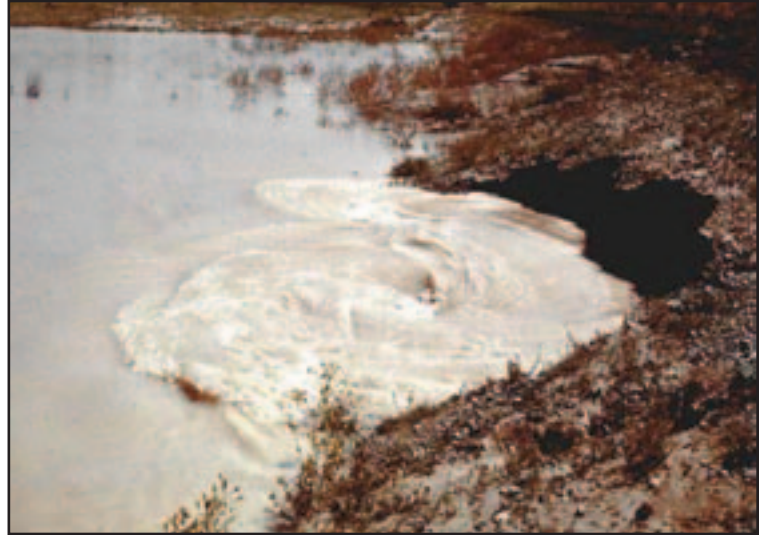
Figure 6—Whirlpool action is an indication of advanced piping.

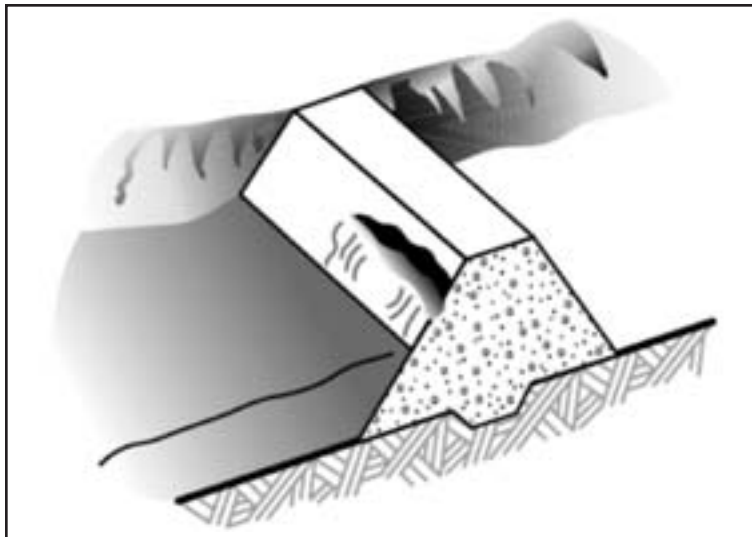
- Foundation movement or a too steep slope can cause earth or rocks to move along a slip plane which can lead to a slump of the embankment.
- Slide movements in the reservoir basin can lead to inlet obstruction or dam failure.

Figure 7—Slide, slump, or slip.

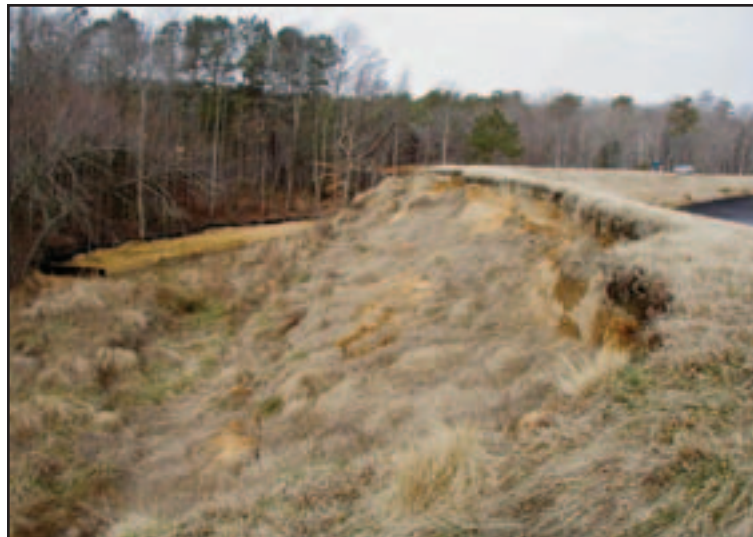
Figure 8—Slumping on the downstream face of a dam.

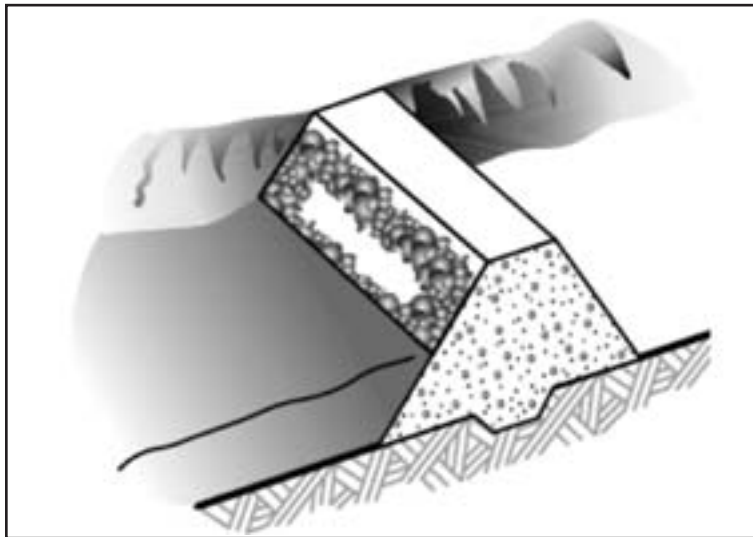
- Poor-quality riprap deteriorates and does not protect the slope.
- Wave or ice action can displace riprap allowing erosion of the bank.
- Similar-sized round rocks may roll downhill and expose the slope.
- Wave action against these unprotected areas decreases the embankment width.

Figure 9—Broken down or missing riprap.

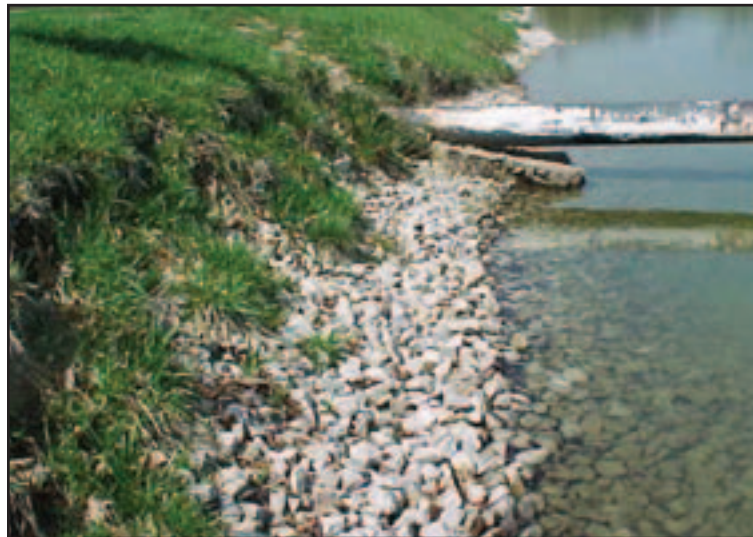
Figure 10—Wave erosion on the unprotected face of a dam.

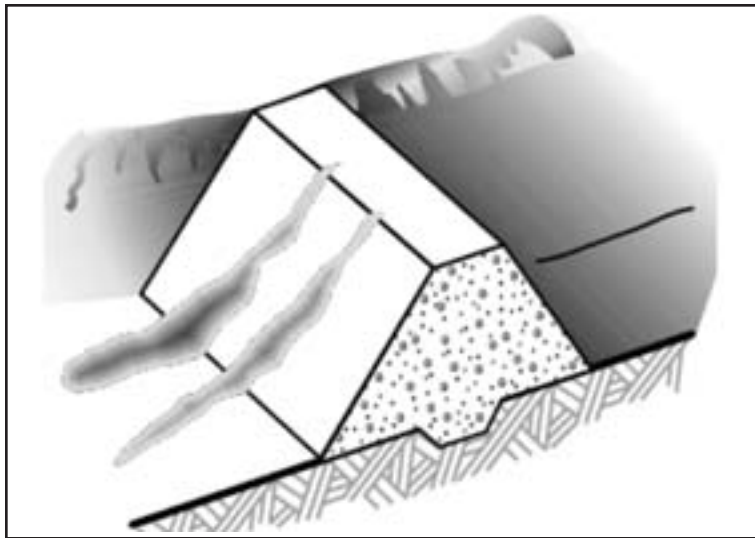
- Water from intense rainstorms or snowmelt carries surface materials down the slope and results in continuous troughs, which can be hazardous if allowed to continue.
- Erosion can lead to deterioration of the downstream slope and failure of the structure.

Figure 11—Erosion.

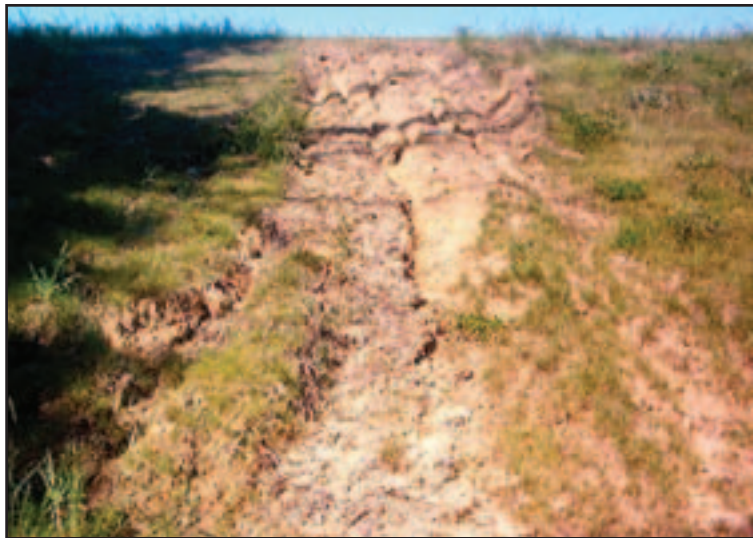
Figure 12—Erosion on the downstream face of a dam.

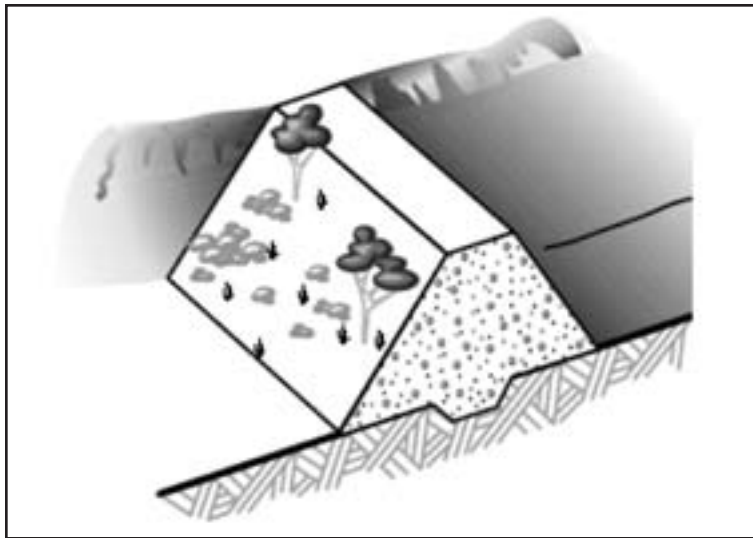
- Natural vegetation (bushes) obscures visual inspection and harbors rodents.
- Large tree roots can create seepage paths.
- Large trees can blow over during a storm and damage the dam, which may cause a breach.

Figure 13—Trees or obscuring vegetation.

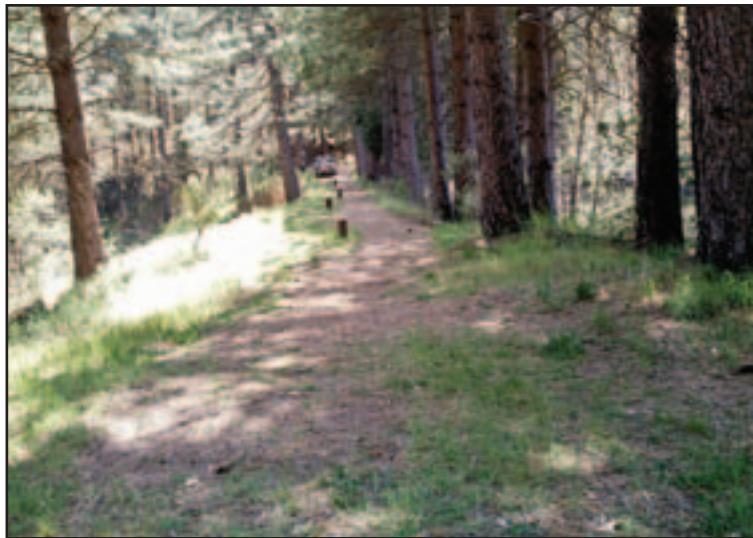
Figure 14—Trees growing on the crest and the faces of a dam.

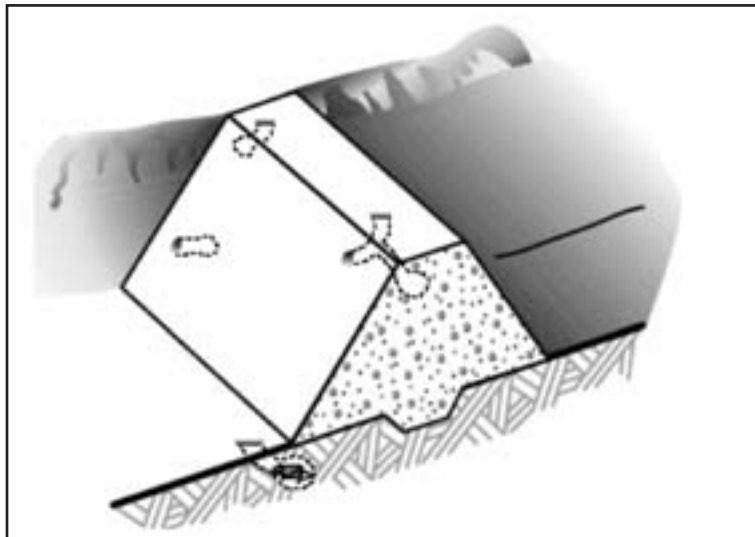
- Cattail-filled areas and areas where trees are close to the reservoir provide ideal habitat and foraging areas for animals.
- An overabundance of rodents increases the chance of animal burrowing, which creates holes, tunnels, and caverns.
- Tunnels may reduce the required length of the seepage path, which could cause a piping problem.
- Tunnels can lead to the collapse of the dam crest and may cause dam failure.

Figure 15—Rodent activity

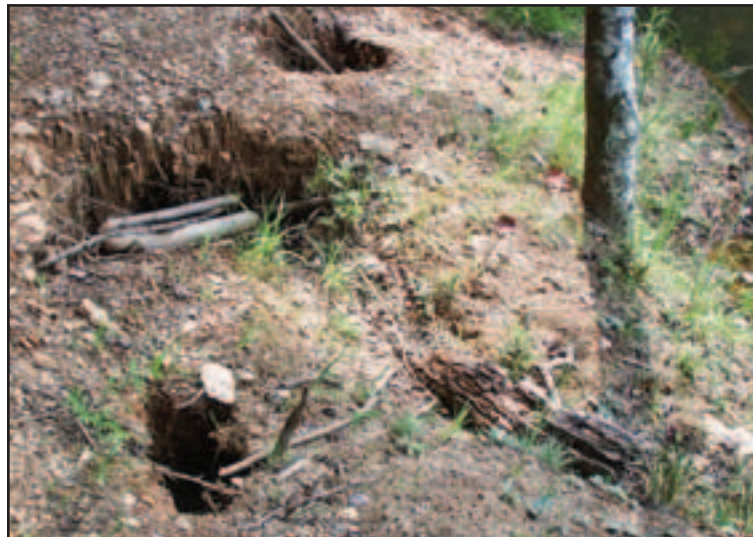
Figure 16—Rodent holes in the dam face can cause dam failure.

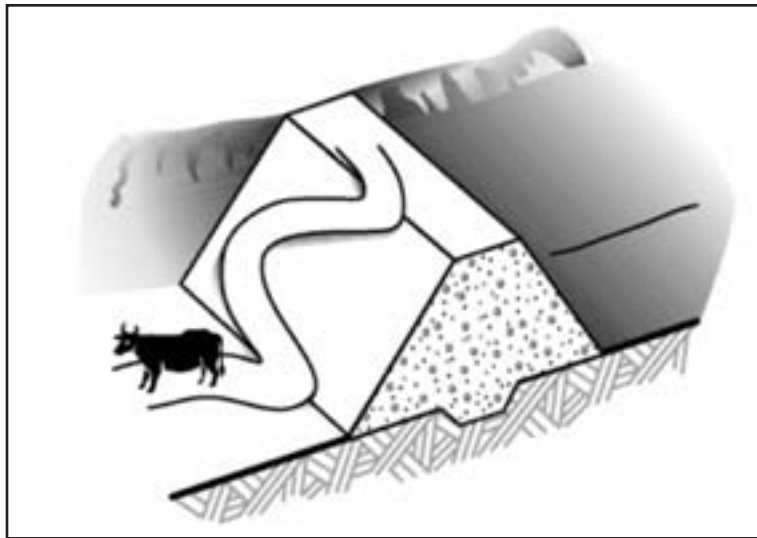
- Livestock paths and activities on the downstream dam face can damage slopes, especially when wet.
- Livestock activities may reduce erosion protection and cause erosion channels.
- Bare areas may allow water to stand and be susceptible to drying cracks.

Figure 17—Livestock and cattle traffic.

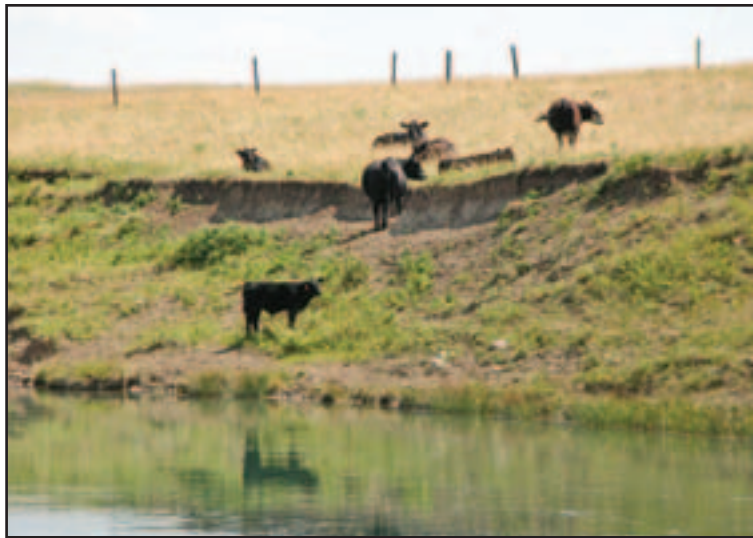
Figure 18—Livestock paths on dam faces can lead to dam erosion.

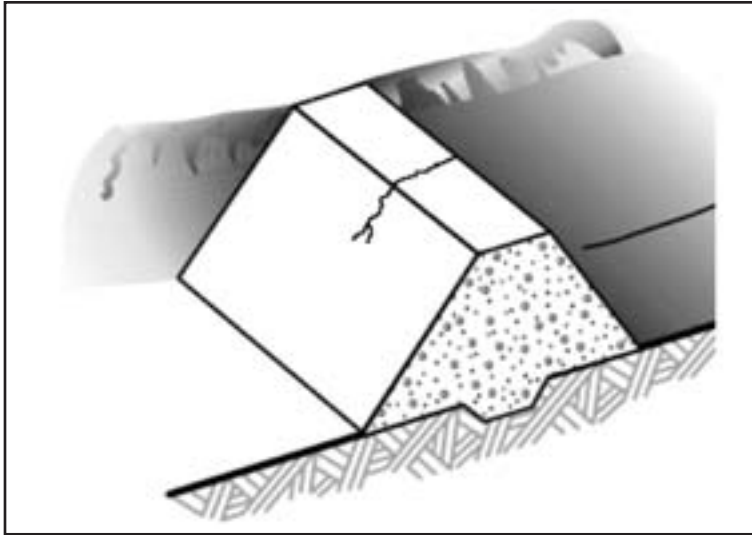
- Uneven movement between adjacent segments of the embankment may cause transverse cracking.
- Deformation caused by structural stress or instability may provide a path for seepage through the embankment cross section.
- If not corrected, cracking creates an area of low strength within the embankment that may lead to future structural movement, deformation, or failure.
- Cracks create a point for water to enter the embankment. Saturation of the adjacent embankment area may occur and could lead to localized failure.

Figure 19—Transverse cracking.

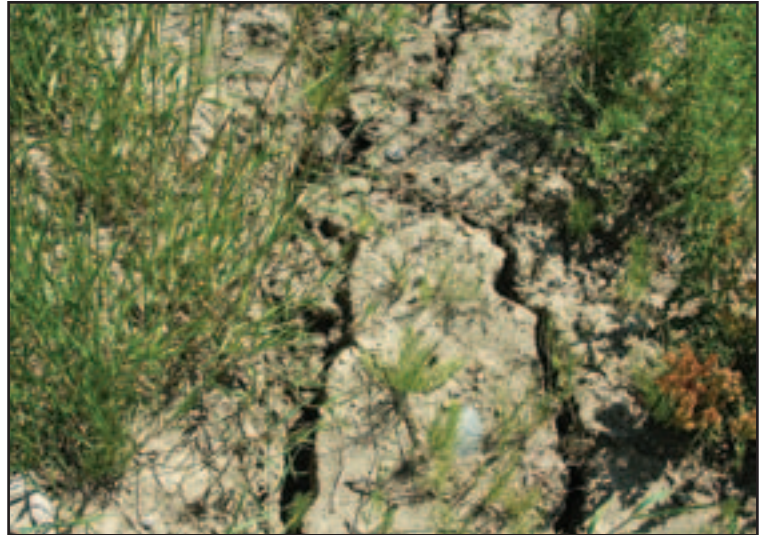
Figure 20—Transverse cracks can be an indication of dam instability.

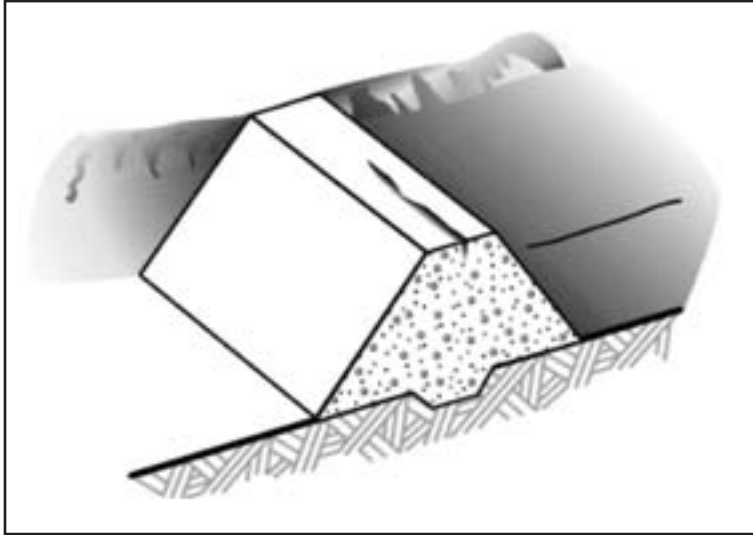
- Uneven settlement between adjacent sections or zones within the embankment may cause longitudinal cracking.
- Foundation failure causes loss of embankment support, which can result in embankment slide.
- Settlement creates an area of low strength within an embankment, which may lead to future structural movement, deformation, or failure.
- Cracks create a point for water to enter the embankment. Saturation of the adjacent embankment area may occur and could lead to localized failure.

Figure 21—Longitudinal crack.

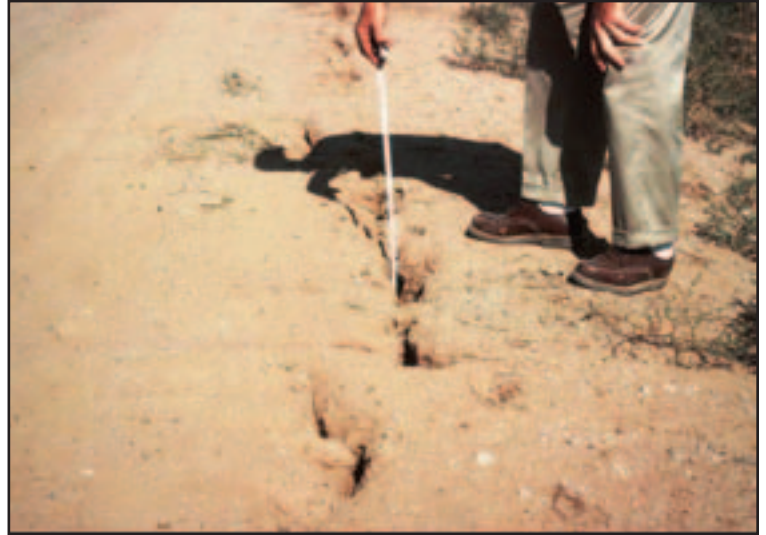
Figure 22—Longitudinal cracks can be an indication of dam instability.

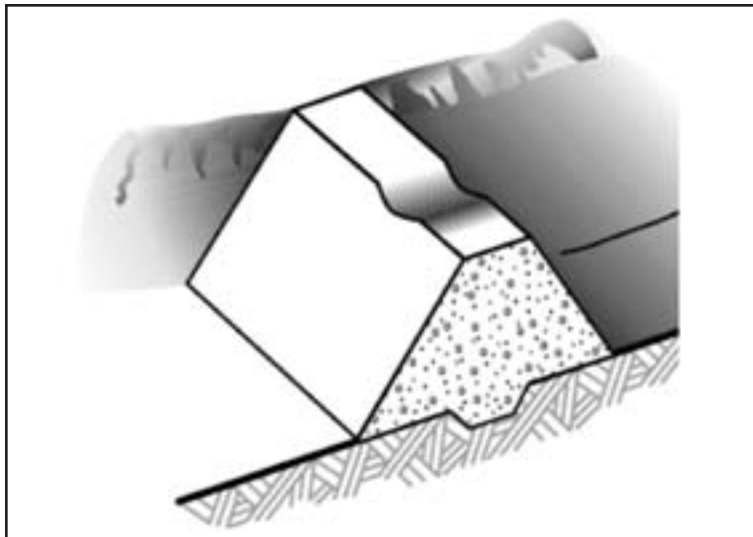
- Excessive settlement of the embankment or internal erosion of embankment material may cause a depression on the top of a dam.
- Foundation spreading upstream and/or downstream, prolonged wind erosion, or improper final grading following construction may cause a low area in the crest of a dam.
- Low areas can reduce the freeboard available to pass flood flows safely through the spillway.

Figure 23—Low area in the crest of a dam.

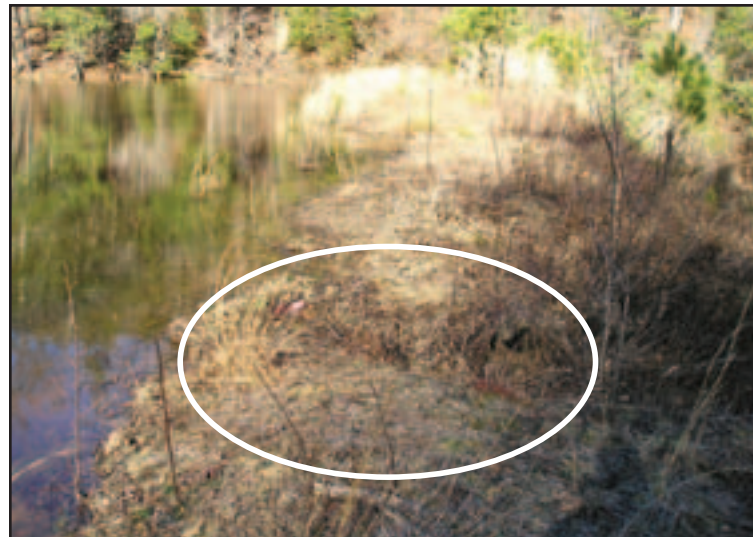
Figure 24—Low areas in the crest of a dam reduce the freeboard.

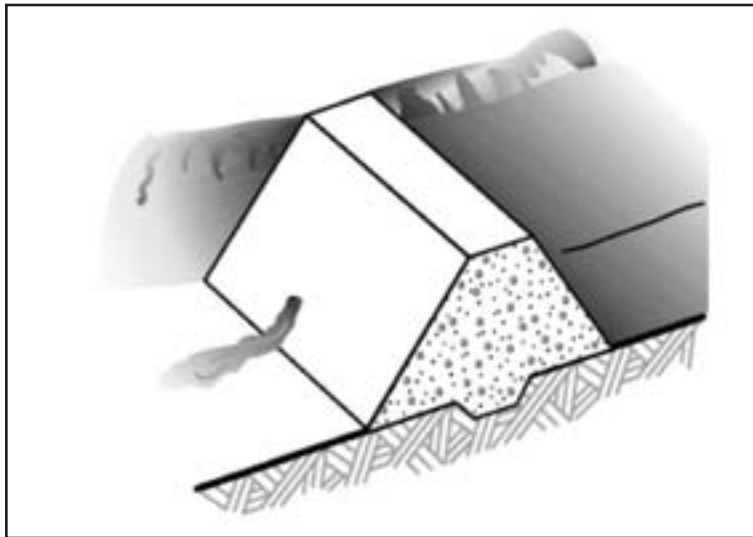
- Water has created an open pathway, channel, or pipe through the dam. The water is eroding and carrying embankment material.
- Surface agitation of water and embankment materials exiting at one point may cause muddy water.
- Rodents, frost action, or poor construction may allow water to create an open pathway or pipe through the embankment.
- Continued flows can saturate parts of the embankment and lead to slides in the area.
- Continued flows can further erode embankment materials and lead to dam failure.

Figure 25—Excessive quantity and/or muddy water exiting from a point.

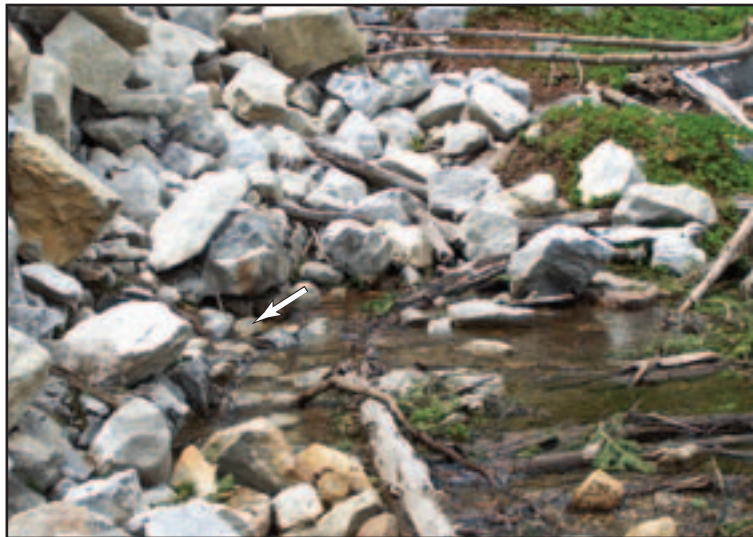
Figure 26—Excessive water piping through the dam at the toe of the embankment.

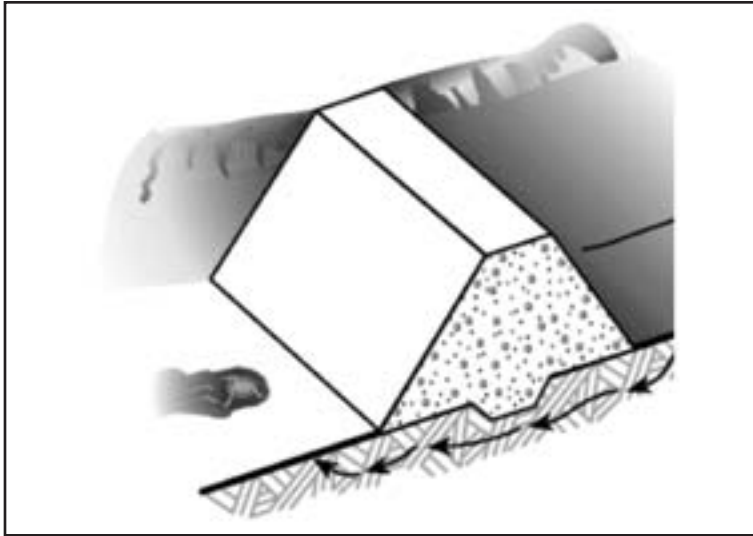
- Some part of the foundation material is supplying a flow path. This could be caused by a sand or gravel layer in the foundation.
- Increased flows can lead to erosion of the foundation and dam failure.

Figure 27—Seepage water exiting as a boil in the foundation.

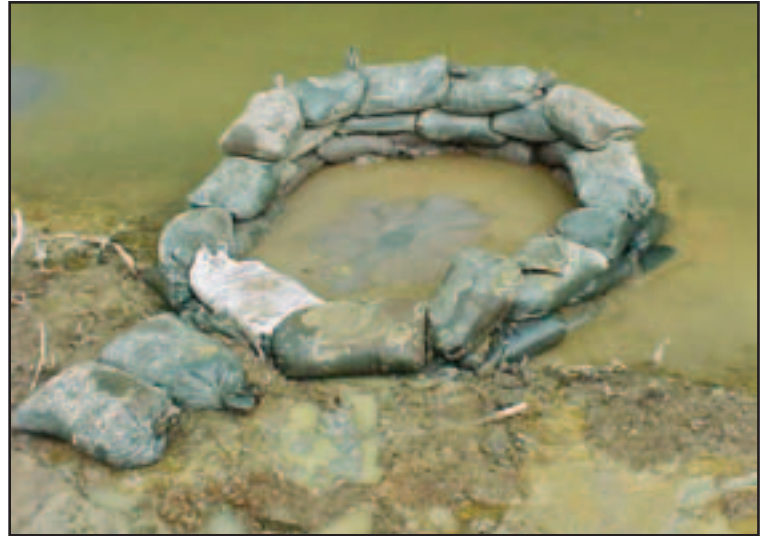
Figure 28— Sandbags surrounding a boil on the downstream side of the dam.

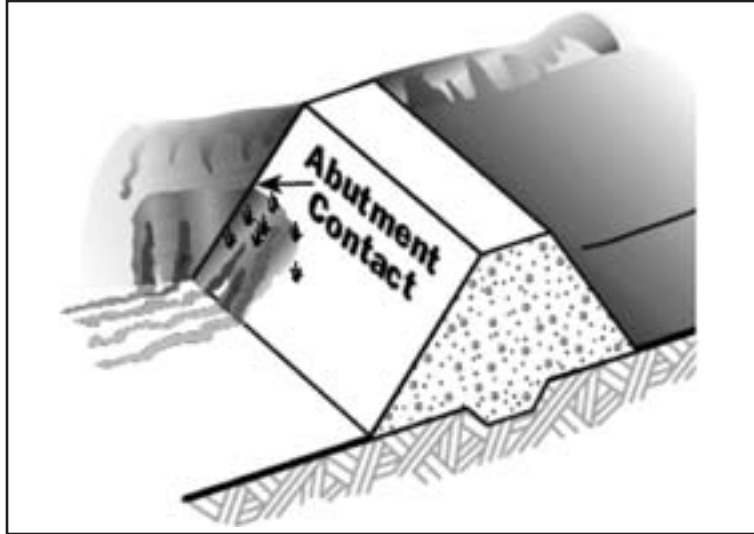
- Water flowing through pathways in the abutment or through the embankment can cause seepage.
- Seepage can lead to erosion of the embankment material and dam failure.

Figure 29—Seepage exiting at the abutment contact (groin).

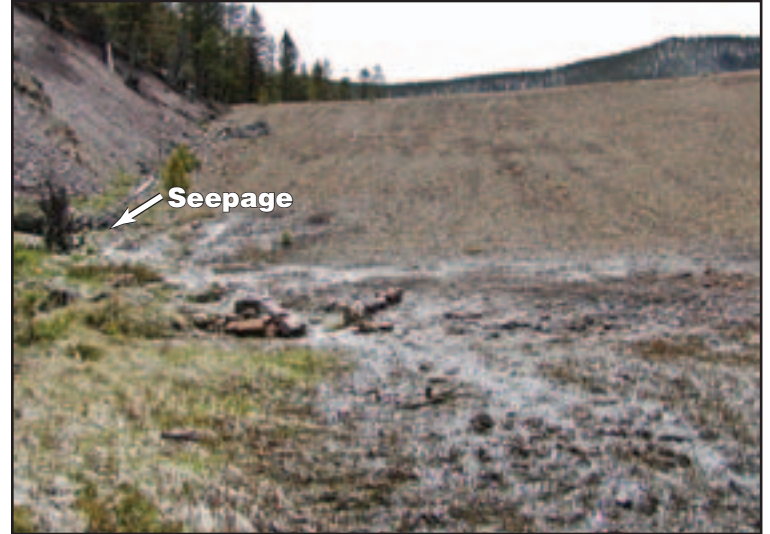
Figure 30—Seepage at the abutment contact (groin) can lead to dam failure.

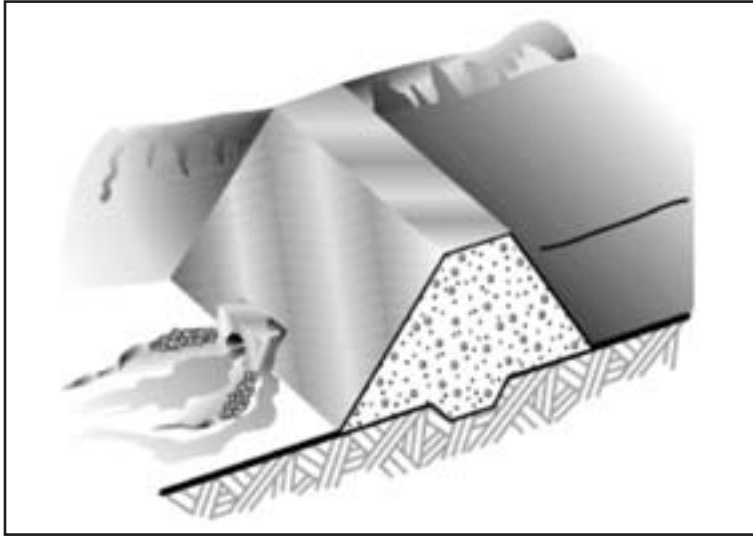
- A break or hole in the outlet pipe or poor compaction around the pipe allows water to flow and creates a pathway along the outside of the outlet pipe.
- Continued flows can lead to embankment material erosion and dam failure.

Figure 31—Seepage water exiting from a point adjacent to the outlet pipe.

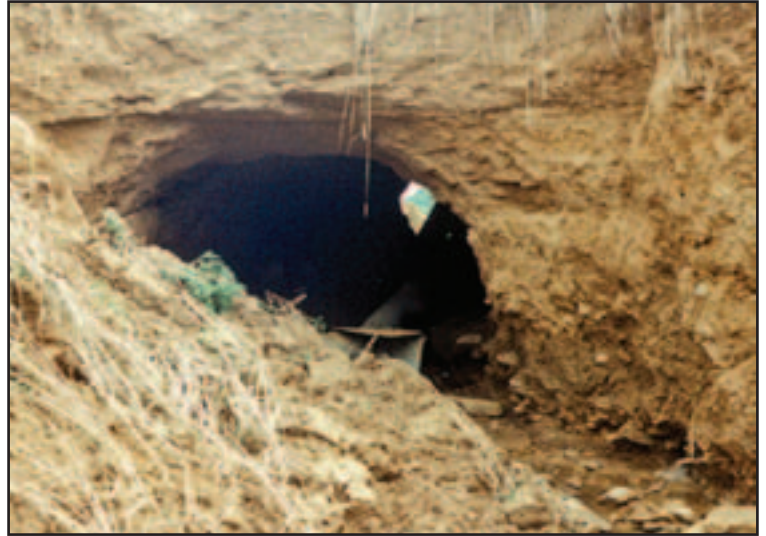
Figure 32—Piping of water alongside an outlet pipe.

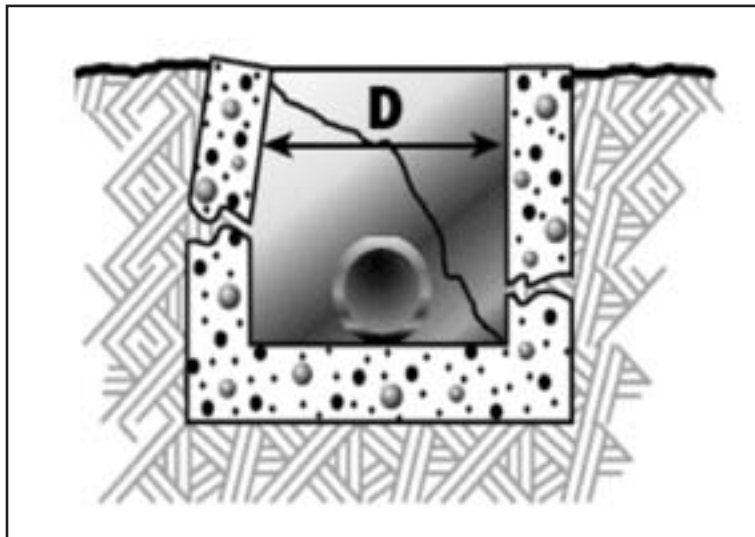
- Excessive side pressures on a nonreinforced concrete structure or poor concrete quality can cause failure of the outfall structure.
- Too steep of a slope can cause rocks to roll down the hill and partially block the outlet.
- The embankment may be exposed to erosion by outlet releases because of loss of an outfall structure.

Figure 33—Failure of a concrete outfall structure.

- Monitor a typical dimension (such as “D” shown in figure 33) to check for progressive failure.
- Repair by patching cracks and supplying drainage around the concrete structure. The entire outfall structure may need to be replaced.
- Repair the slopes and place riprap to stabilize them.

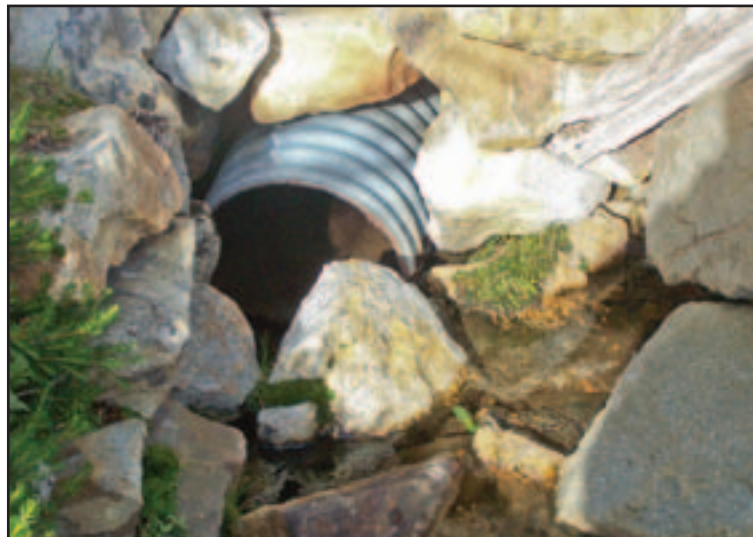
Figure 34—Rock failure around an outlet pipe.

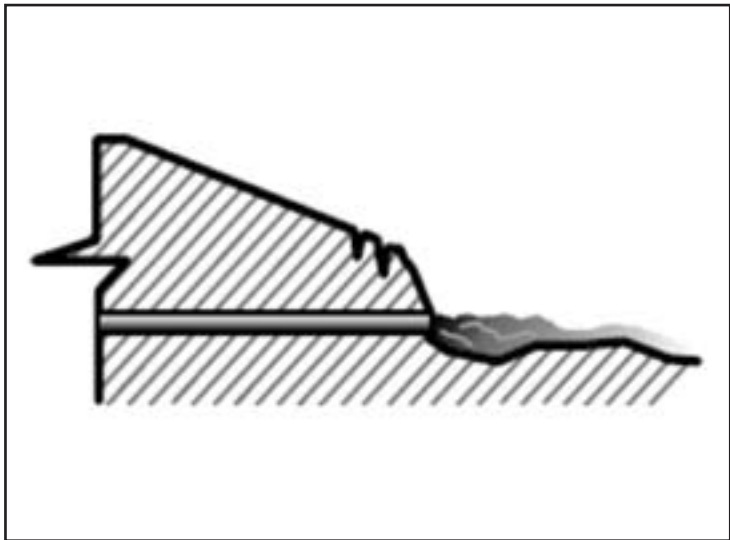
- The outlet pipe may be too short and cause a scour hole.
- No energy-dissipating pool or structure at the downstream end of the conduit can cause a scour hole.
- Erosion of the toe of the dam makes the downstream slope too steep and causes progressive sloughing.

Figure 35—Outlet releases erode the toe of the dam.

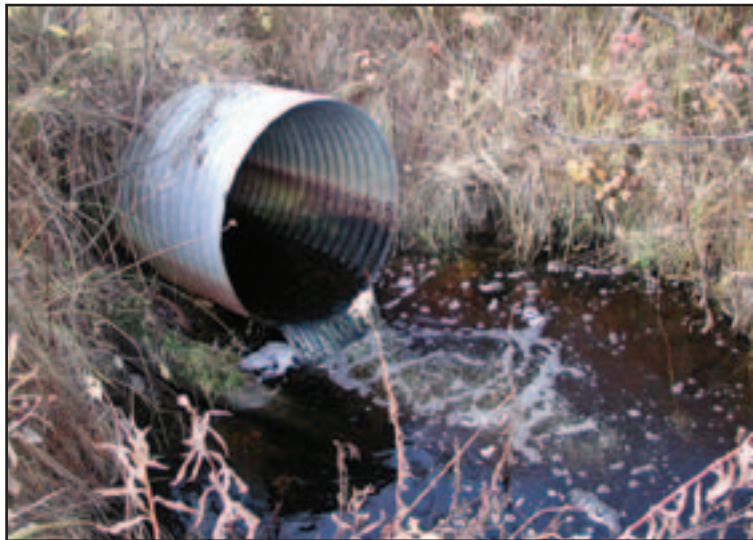
Figure 36—A scour hole at an outlet erodes the toe of the slope.

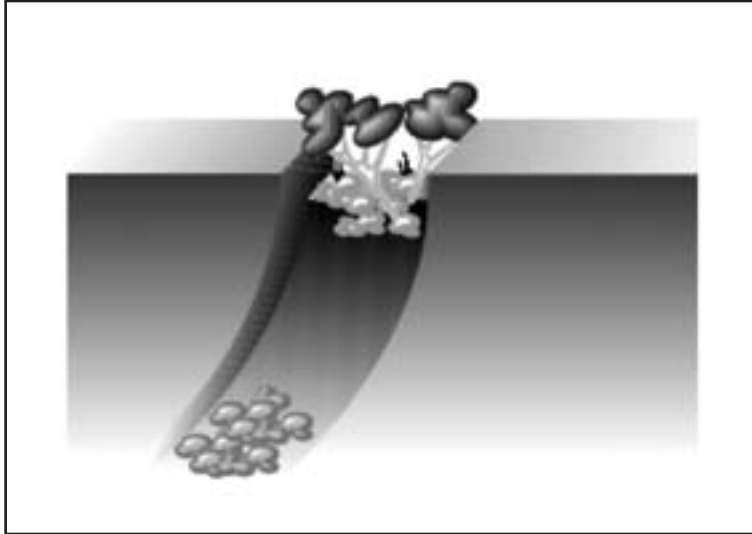
- An accumulation of slide materials, dead trees, excessive vegetative growth, etc., in the spillway channel can reduce waterway capacity.
- Reduced discharge capacity may cause the spillway to overflow and the dam to overtop. Prolonged overtopping can cause dam failure.

Figure 37—Excessive vegetation or debris in a spillway channel.

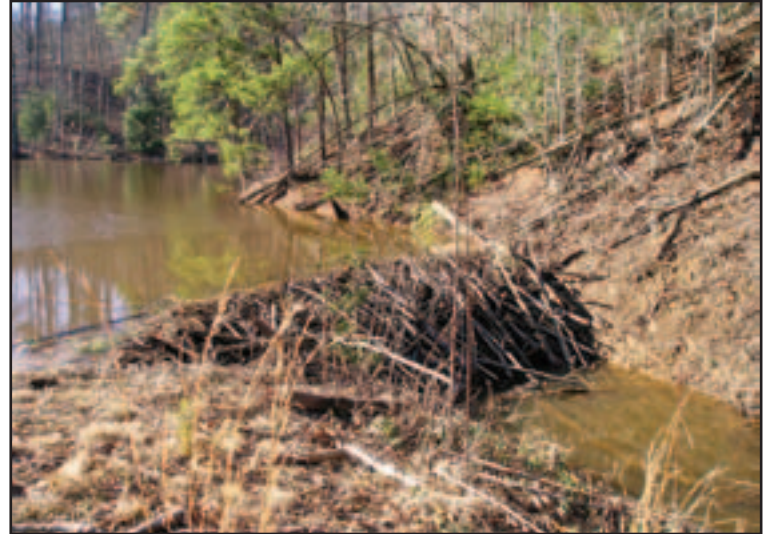
Figure 38—A blocked spillway channel may cause overtopping of the dam.

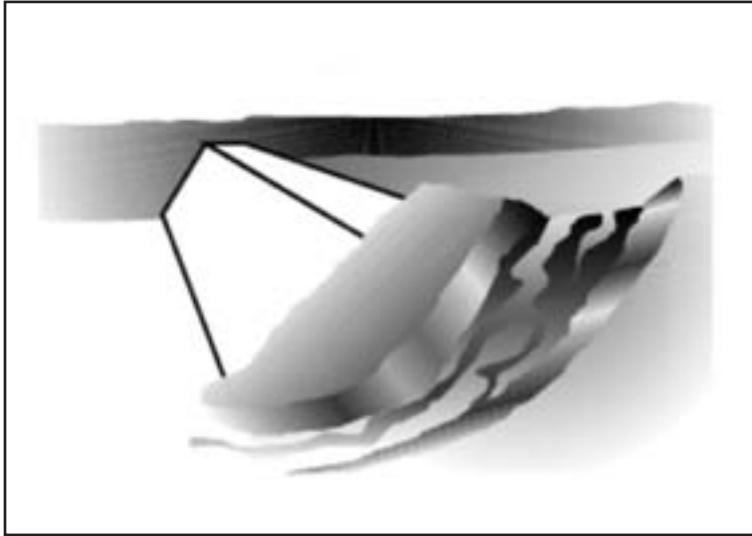
- Surface runoff from intense rainstorms or flow from the spillway carries surface material down the spillway causing continuous troughs.
- Livestock traffic creates gullies where runoff flow can concentrate.
- Unabated erosion can lead to slides, slumps, or slips, which can result in reduced spillway capacity. Inadequate spillway capacity can lead to embankment overtopping and result in dam failure.

Figure 39—Erosion channels.

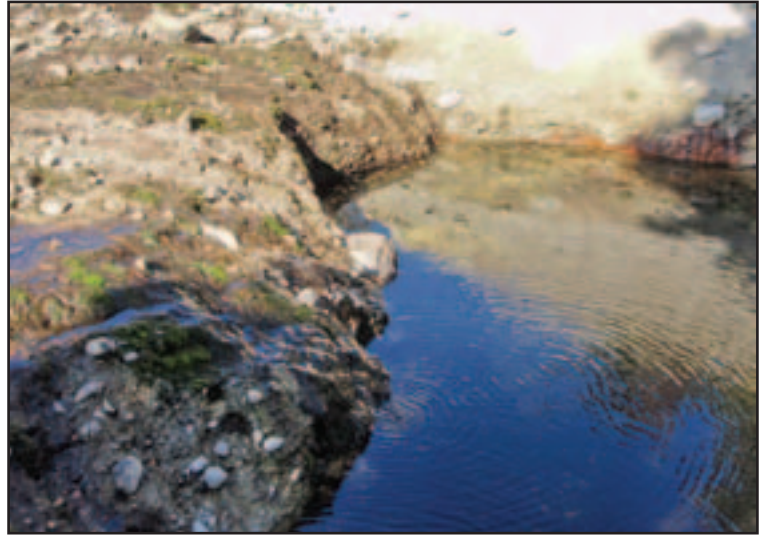
Figure 40—Erosion of the spillway channel may lead to slumps or slides of the spillway sides.

- Photograph the condition and bring it to the attention of the engineer.
- Replace eroded material with compacted fill to repair damaged areas.
- Revegetate the areas if appropriate.
- Install suitable rock riprap to protect against future erosion.
