# U.S. Environmental Protection Agency Rockwell International Wheel & Trim Site

### Grenada, Mississippi

#### **Frequently Asked Questions**

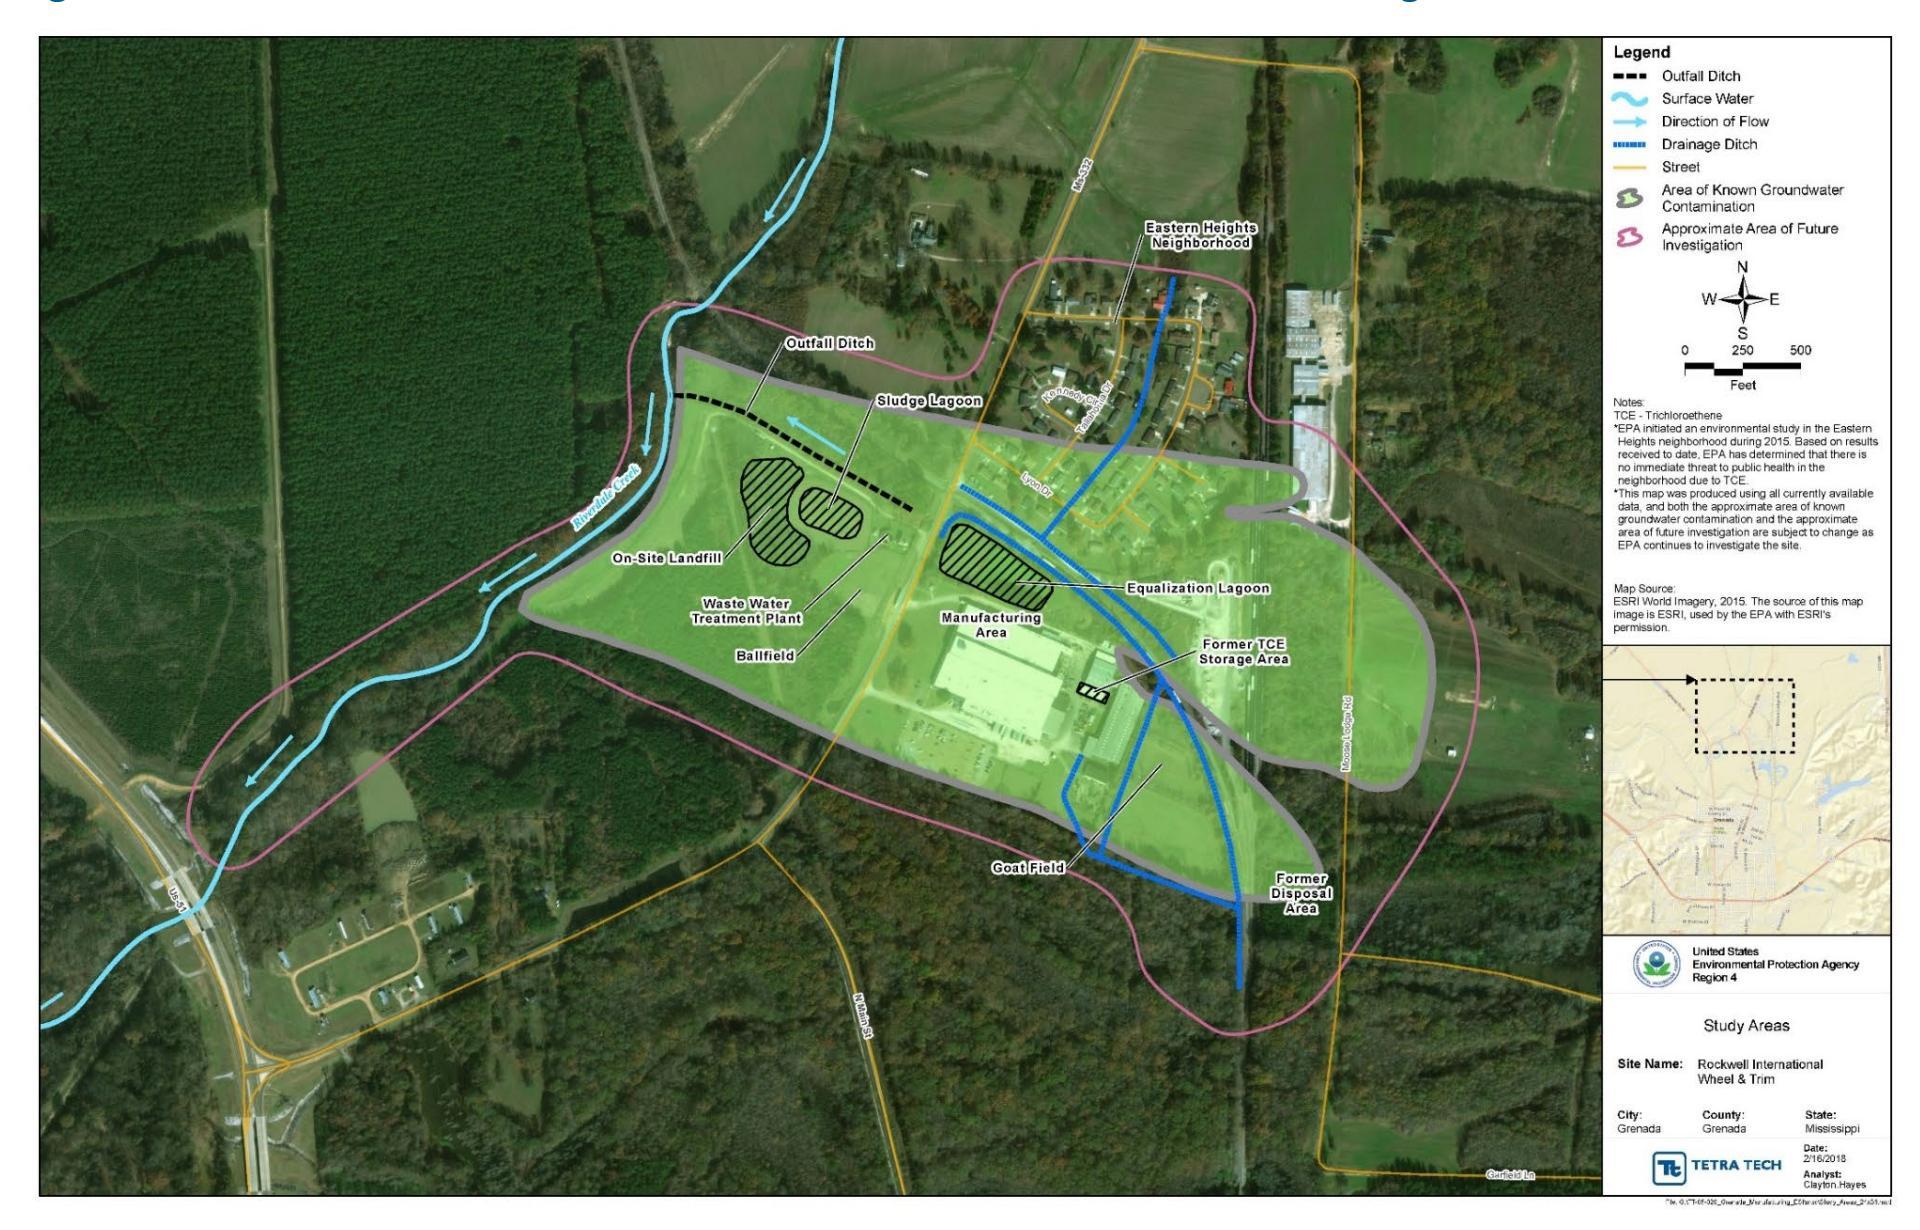
#### Figure 1: Area of Known Groundwater Contamination and Area of Current Investigation

The EPA is overseeing activities to begin treating contaminated groundwater. The EPA is also working to identify any areas where contamination remains in place to finalize a cleanup plan for the Site. Figure 1 (next page) shows the areas of known contamination outlined in green and areas needing additional investigation in pink.

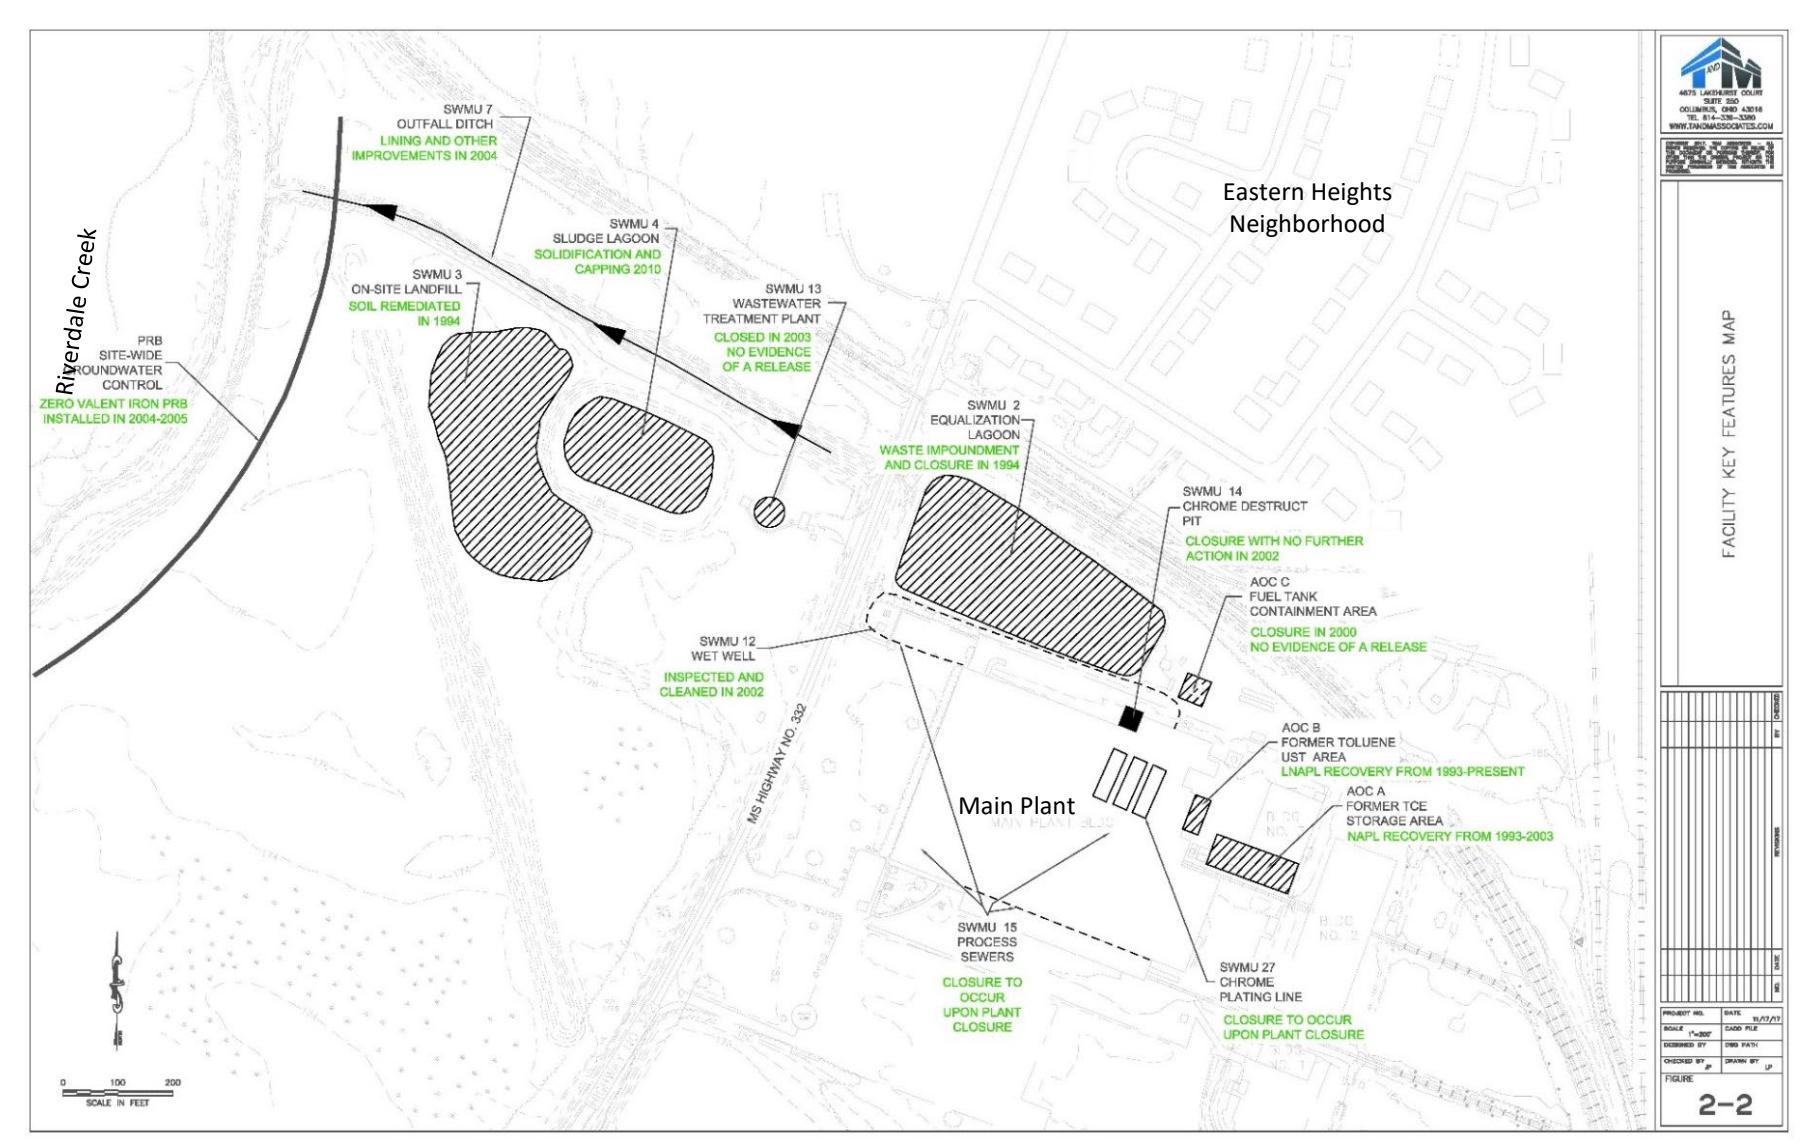
#### Figure 2: Map Showing Where RCRA Cleanup Occurred<sup>1</sup>

Between 1994 and 2017, the facility completed cleanup activities at different source areas. These included collecting and removing the waste, groundwater and soil treatment, soil excavations and work to clean up the contamination of Riverdale Creek. These activities are included in detail in Figure 2 and Table 1 (next pages).

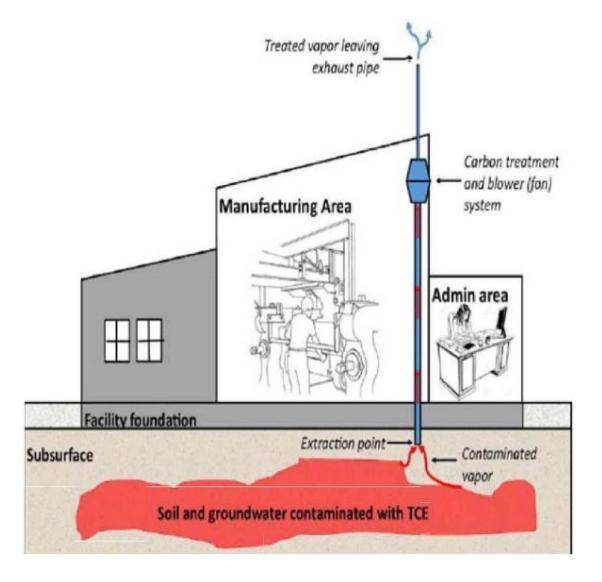
Figure 3: Sub-slab Depressurization System

The EPA conducted a TCRA in December 2017 to restart the sub-slab depressurization system (Figure 3) at the facility to prevent vapors from below ground from entering the facility. This system will remain in place until the concentrations of contamination in the building air have been shown to be consistently below health-based risk levels for workers even when the system is not operating. This will likely require source material removal from under the facility.

- Sub-slab depressurization system A system below a building's foundation designed to draw up TCE vapors out of the ground through an enclosed pipe, into a carbon filter that treats the air and then releases the treated air to the outside.

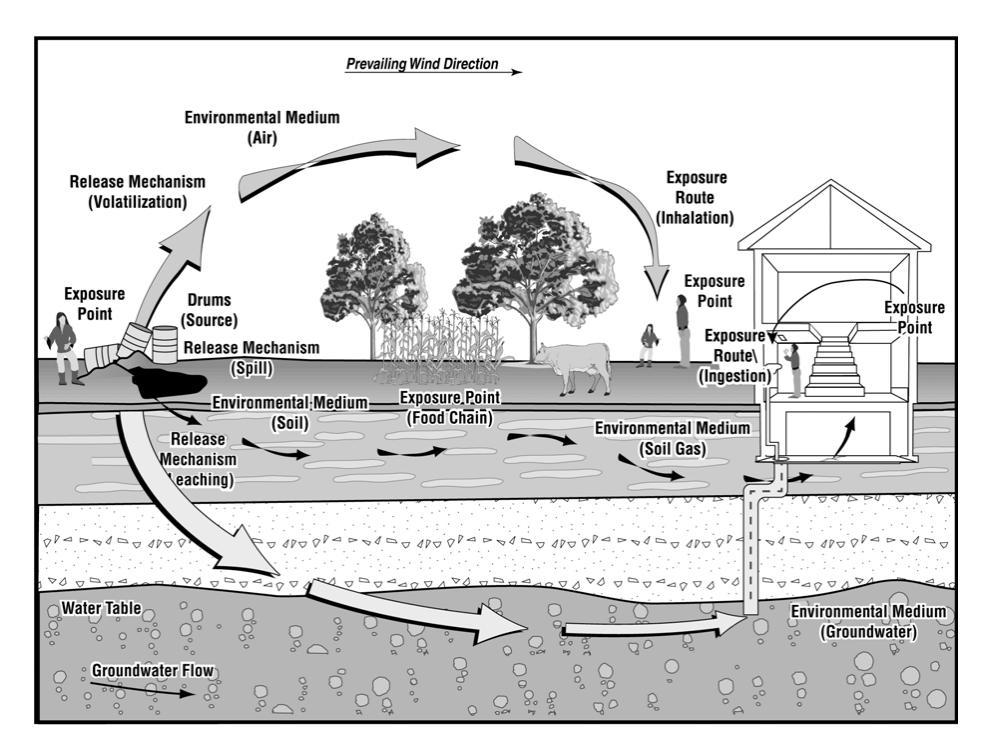
Figure 4: Example of a CSM

The conceptual site model (CSM) is an important tool used by the EPA to understand the story of how the site has become contaminated and how the contamination moves in the surrounding environment and potentially exposes people or wildlife. The CSM usually is written in a cartoon-like presentation (Figure 4) that identifies:

- Contaminant sources areas at the facility or waste disposal locations that may have released contaminants to the soil, groundwater, surface water, or air
- Migration pathways describes the way contaminants move from a spill or release to nearby receptors
- Receptors are the people or wildlife that could come in contact with the contamination
- Exposure pathways describes the way that a contaminant can enter bodies of people or wildlife (e.g., ingestion, skin contact, or breathing contaminated air).

The CSM for the site provides the EPA with a research-based picture to see where sampling is needed and

where remedial action may be required. As data is collected, the CSM is updated to help the EPA narrow in on where remedial decisions need to be made.

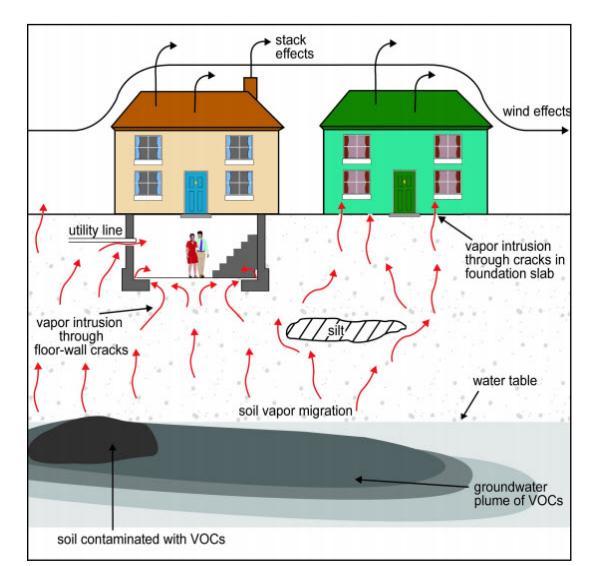
Figure 5: Movement of soil and groundwater vapors to indoor air

The movement of vapors from any source below ground surface (deep soil, groundwater, waste) into a building above. Figure 5 shows how contamination can move into indoor air through vapor intrusion.

A mitigation system can be installed to prevent vapors from entering a building from below ground sources and vent to outside and/or treat the vapors. This is the reason the system was installed at the facility. The EPA has not found TCE in the indoor air above levels that would require further action in any home.
