Coastal Streams and Habitat Initiative

A Conservation Action Plan for Nine Mississippi Coastal Streams

September 1, 2016

The Nature
Conservancy

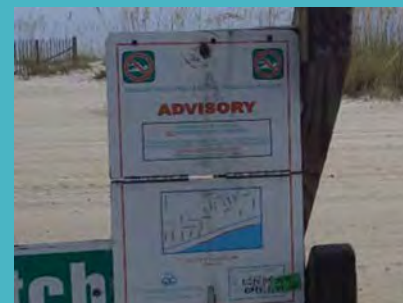
Organic Pollution

Organic Pollution includes volatile, semi-volatile, and other organic compounds and pathogens in streams and rivers above ambient levels that degrade the target. Organic pollution often originates from wastewater, industrial effluents, and agricultural wastes (USEPA 2013). Like chemical pollution, the effects of organic pollution on aquatic ecosystems can be short-term to chronic, with a wide range of outcomes including physical impairment to direct killing of biota (USEPA 2013). Examples include *E. coli* and other oxygen-depleting pathogenic organisms or substances from sources, detergents, hydrocarbons, polychlorinated biphenyls, and inorganic agricultural chemicals, such as atrazine.

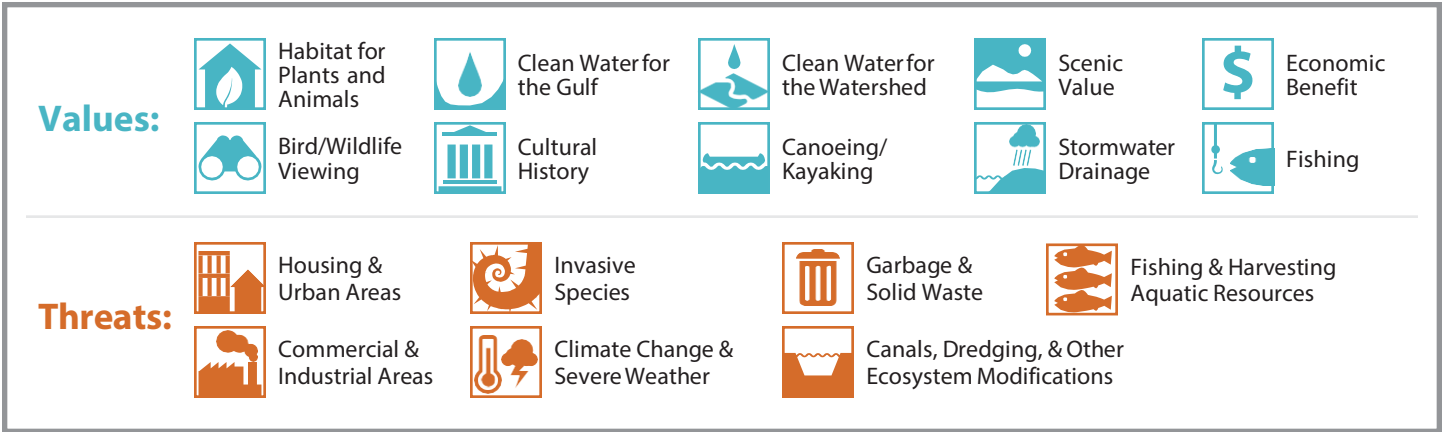
**Figure 2-1
Magnolia Bayou Conservation Strategies**

Conservation Strategies and Benefits to Streams

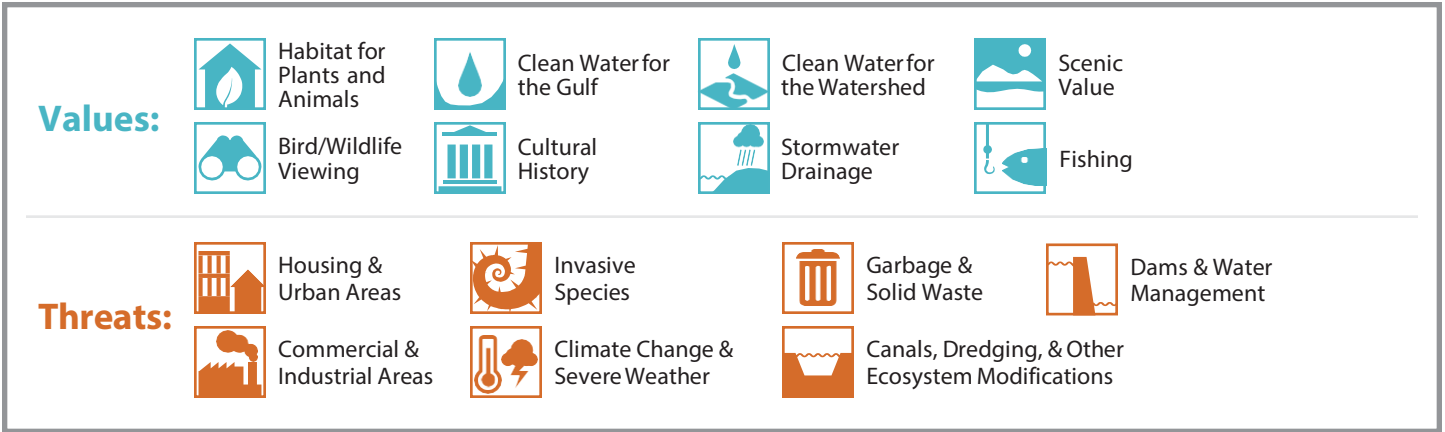
Figure 4-1
Bear Point Bayou Conservation Strategies

Conservation Strategies and Benefits to Streams

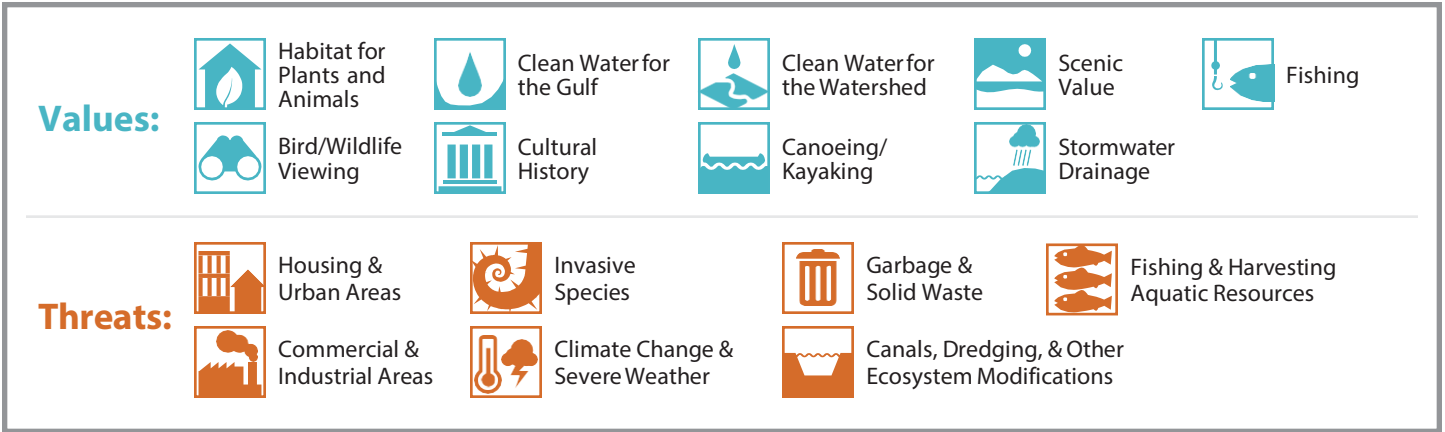
**Figure 5-1
Turkey Creek Conservation Strategies**

Conservation Strategies and Benefits to Streams

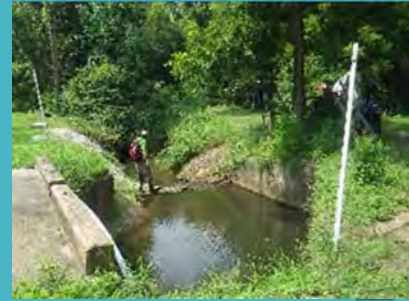
Bank erosion and streambed sedimentation

Impervious surfaces within the watershed likely cause an increase in water volume within Coffee Creek. Stormwater is not absorbed readily and runs into the creek at a greater velocity and volume, resulting in incised channels and more severe flooding impacts.

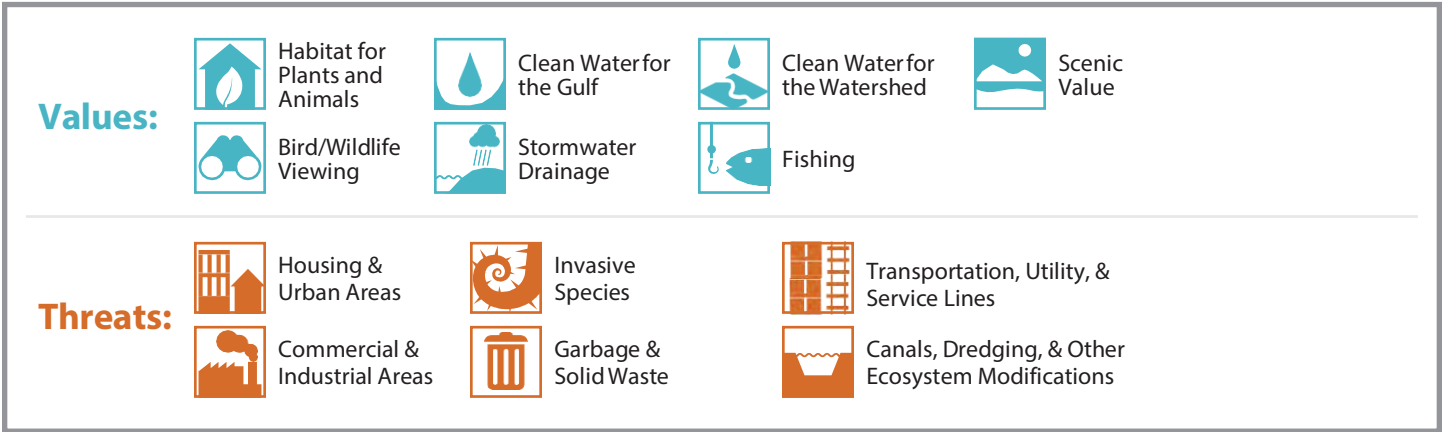
Figure 6-1
Coffee Creek Conservation Strategies

Conservation Strategies and Benefits to Streams

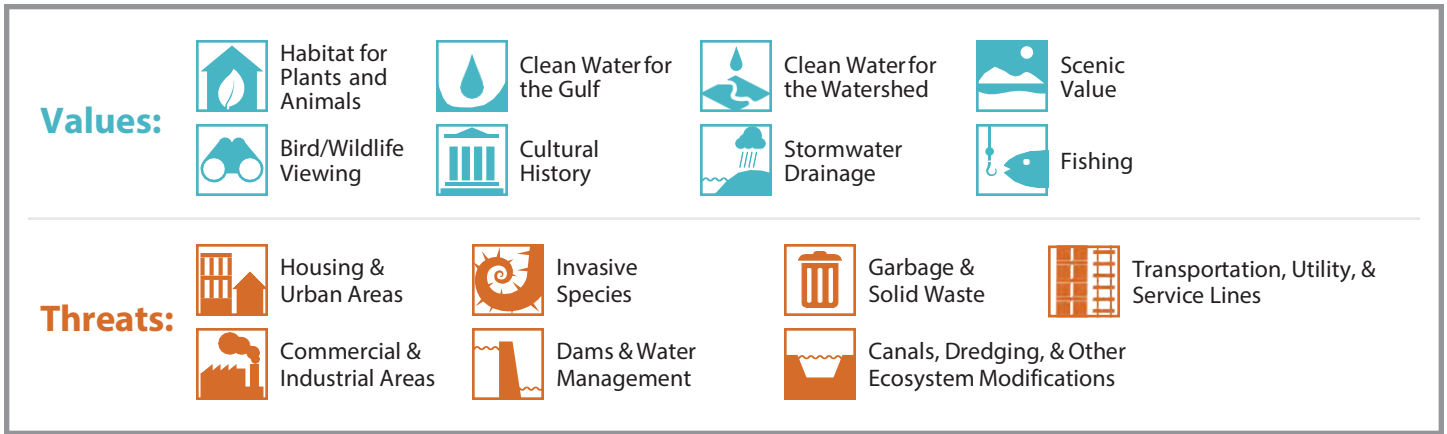
Figure 8-1
Oyster Bayou Conservation Strategies

Conservation Strategies and Benefits to Streams

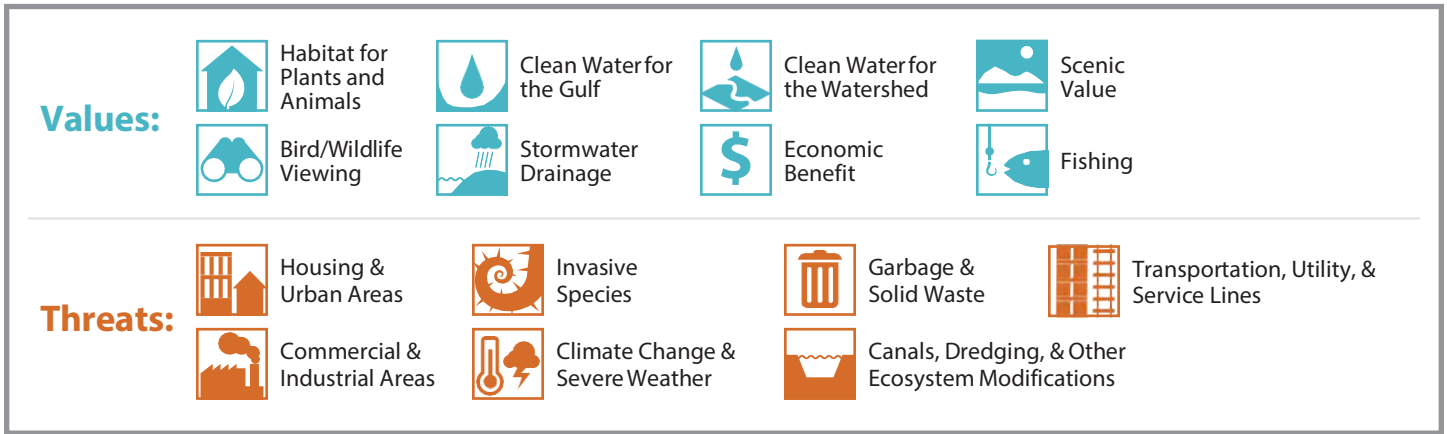
Figure 9-1
Rhodes Bayou Conservation Strategies

Conservation Strategies and Benefits to Streams

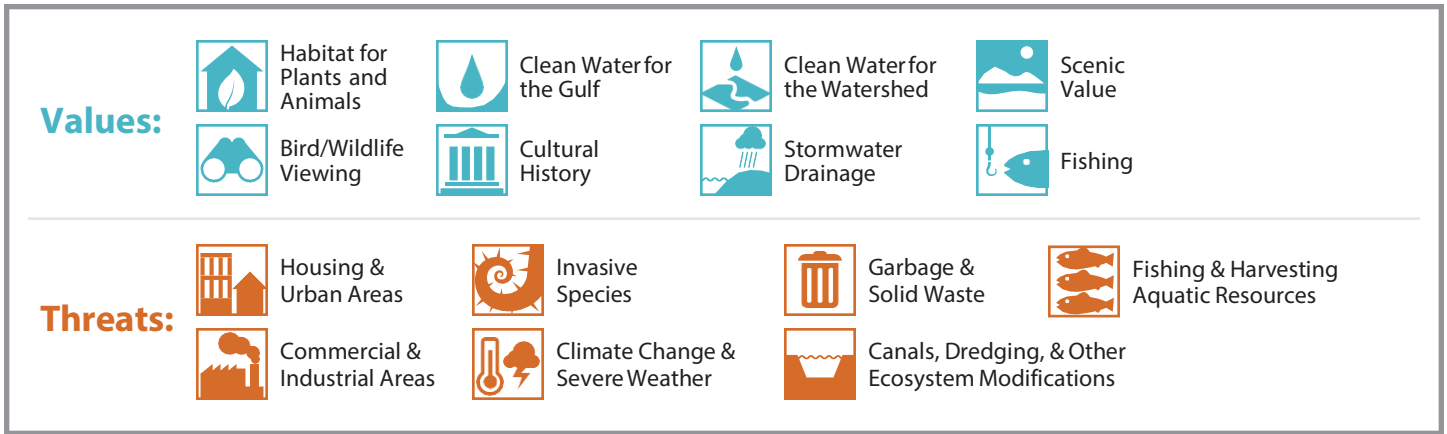
Figure 10-1
Bayou Chicot Conservation Strategies

Conservation Strategies and Benefits to Streams
