FACT SHEET 2019

INTRODUCTION:

The Mississippi Department of Environmental Quality (MDEQ) conducted soil sampling and analysis in the Airport Circle Community in Grenada, MS, on August 21, 2018. The objective of the soil sampling activities was to assess if any contaminants were present in the Airport Circle Community above any of the applicable soil remediation standards or if no further action (investigation or remedial action) was required. The soil samples were analyzed to determine the presence (and/or absence) of volatile and some semi-volatile organic compounds. In addition, water samples were taken during this investigation as part of a precautionary approach to protect public health.

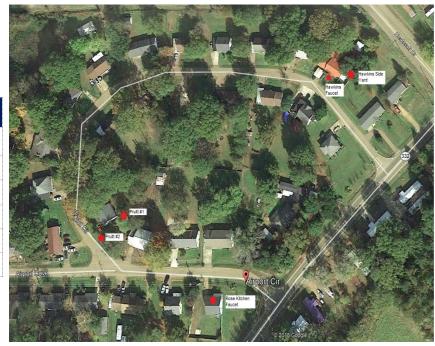
TABLE #1 LOCATION OF AIRPORT CIRCLE COMMUNITY SAMPLES

Sample Site	Type of Sample		
Pruitt Backyard 1	Soil		
Pruitt Backyard 2	Soil		
Hawkins Side Yard 1	Soil		
Hawkins Front Faucet	Water		
Rose Kitchen Faucet	Water		
Hydrant by Church	Water
